Determining the technical condition of steel flue gas conduit shafts' hot-dip galvanisation, illustrated with the example of chimney stacks at the 'CZAJKA' sewage treatment plant in Warsaw

Keywords: hot-dip galvanisation, chimney, Sandelin effect.

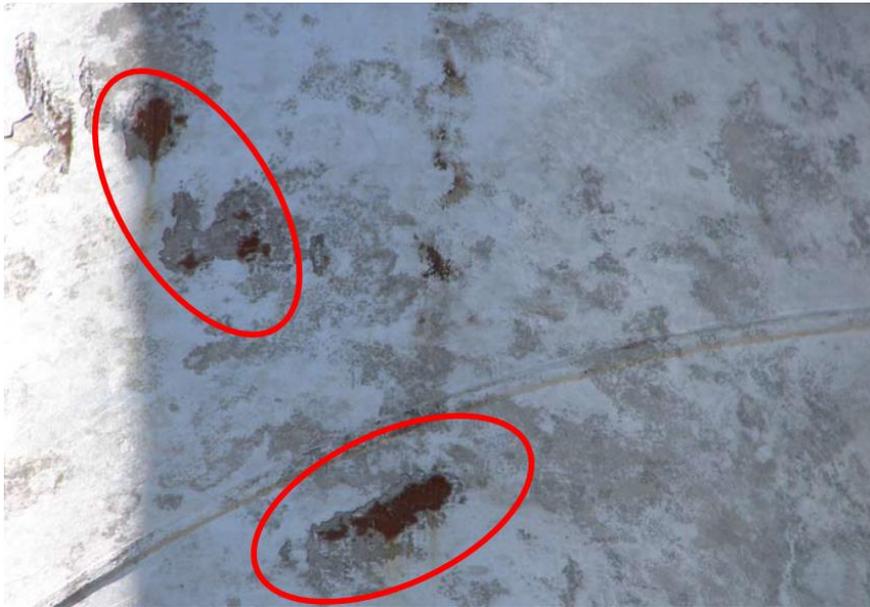
High degree of corrosion to the sub-coating material is a symptom indicating that the zinc coating is in a poor condition. See Fig. 2 for a fragment of the load bearing shaft's surface. Oxidation has set in to the sub-coating material as a result of atmospheric oxygen ingression under the zinc coating – iron oxides have developed in the form of brown deposits and these in turn have caused the coating to flake. The corrosion is uniform and does not weaken the material.

Fig. 2. Surface oxidation of the material under the coating as a result of zinc coating flaking off (marked in red).

- chamfering sharp edges of steel elements;
- re-galvanising the steel structure;
- ensuring the re-galvanised steel structure is correctly protected against water and humidity.

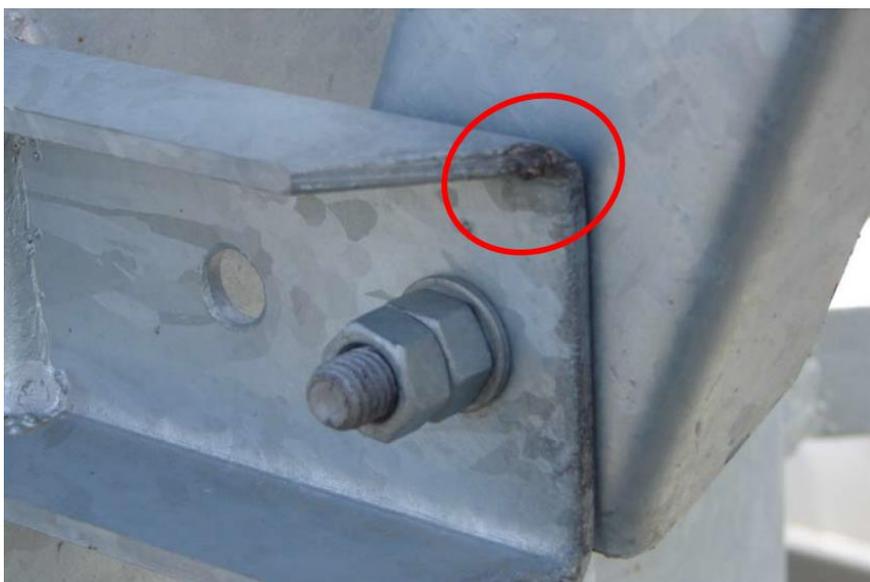
Fig. 3 shows a badly chosen chamfering angle for a profile edge, which caused uneven application of the zinc coating. As a result, the thickness of the zinc coating in this area is less than that on a smooth surface and as such it suffered damage. This resulted in the coating flaking off and subsequent corrosion appearing on the original material's surface in the form of iron oxides.

Fig. 3. Appearance of corrosion in the form of oxidation on a profile edge (marked in red).

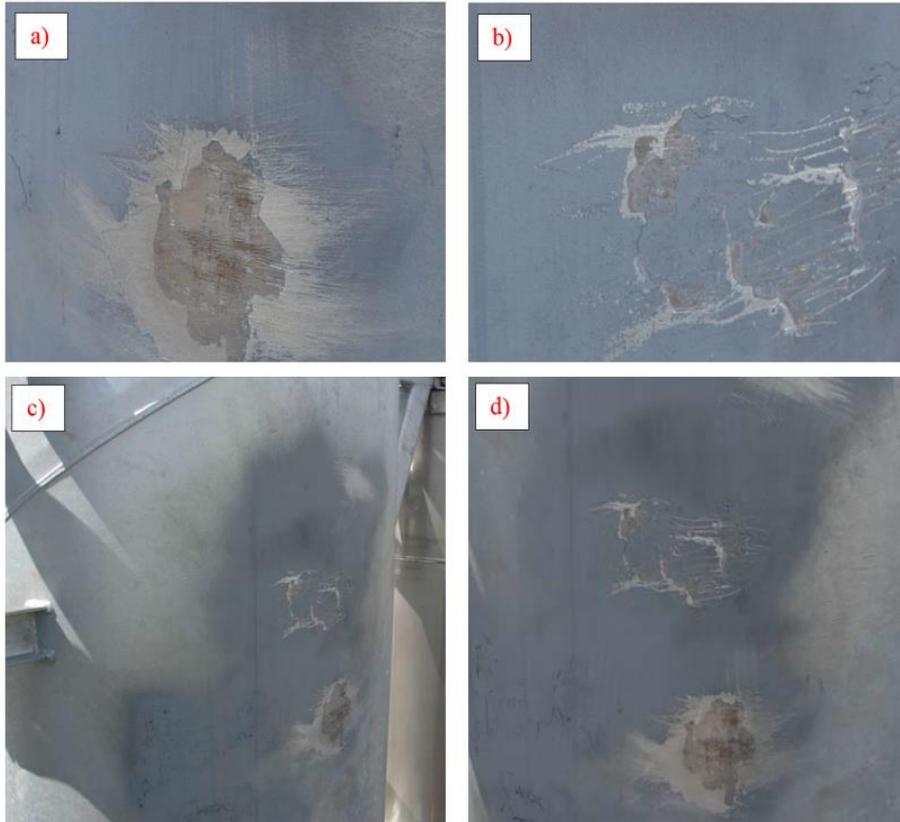
Zinc coating defects shown in Figures 2, 4 a-d and 5 a-b have been caused by the Sandelin effect. The phenomenon is caused by incorrect silicon content in the structure of the sub-coating material. The flaking zinc coating shown in Fig. 4 a-d is caused by non-uniform silicon content in the steel or by the so called scaling effect of rolled surfaces. The scaling phenomenon results from rolling defects. A small quantity of zinc penetrates under a flaking part of the original material. Secondary Fe-Zn phase crystallisation results in the coating flaking off.

Fig. 4 a-d. Loss of surface zinc coating as a result of local Sandelin effect.

The data yielded by the analysis allows one to conclude that ordinary structural St3S grade steel was used for the chimney load bearing shafts. Such steel, unlike higher quality structural steel, has wide alloying element content limits. The silicon level content determined by the analysis of samples collected at two locations from the shaft does not indicate the occurrence of the Sandelin effect. The homogeneity of alloying elements in St3S grade steel is not observed as rigorously as for higher quality steel, hence their content varies across different areas of the chimney shafts and the Sandelin effect occurs locally.

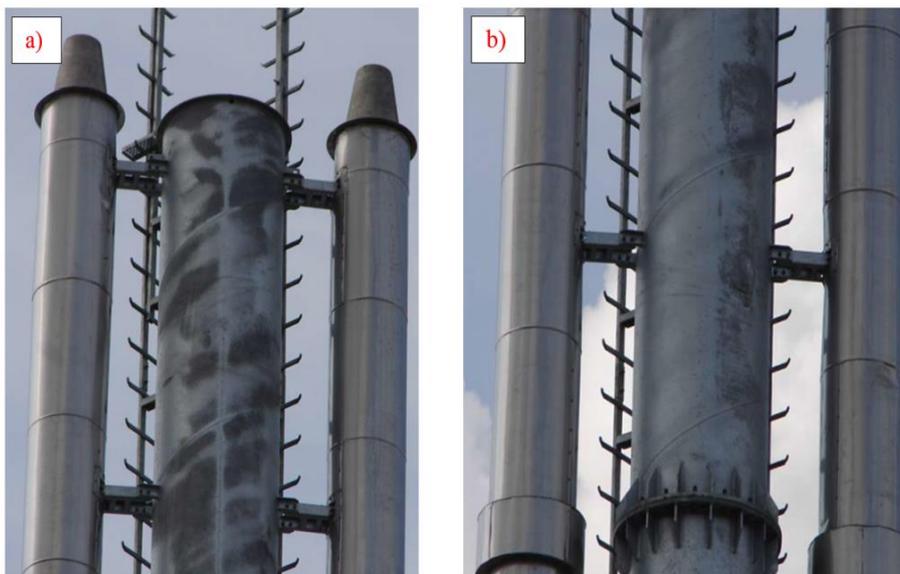
Fig. 5 a-b. Changing colour of the load bearing shaft as a result of the Sandelin effect.

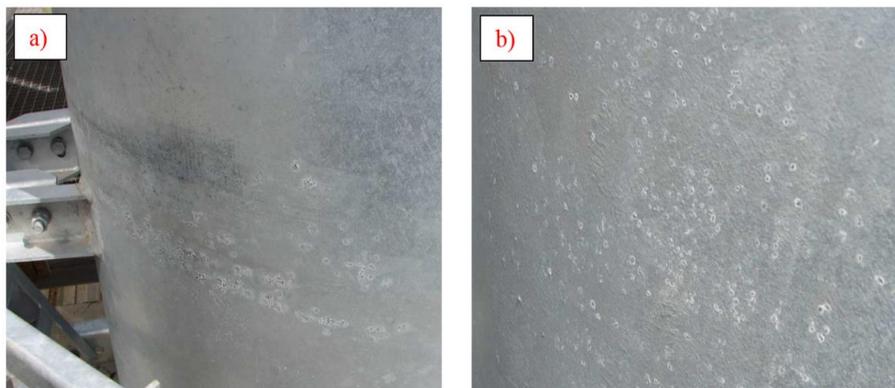
Corrosion typical for a zinc coating is shown in Fig. 7. It is a type of selective corrosion that only affects the hard zinc particles in the coating. This is due to the presence of hard zinc in the zinc bath. Hard zinc particles should be regularly removed from the zinc bath. Otherwise, they form deposits on the surface of the coating and come into contact with atmospheric oxygen [7].

A separate instance of 'white rust' is caused by improper storage of elements immediately after applying the zinc coating. Elements should be stored in such a way as to allow for sufficient air circulation between them until a protective layer develops on the surface in the form of zinc carbonate patina [9].

Fig. 7. 'White rust' on the surface of zinc coating.
