Road bridge reconstruction design analysis

Abstract: This paper presents a case study entailing the reconstruction of a road bridge. The original timber construction low-level bridge with rolled steel girders had lost its performance parameters due to biological corrosion of the structural timbers. The support piles were defective. The structure was taken out of use and a solution was proposed in the form of a composite span structure founded on prefabricated reinforced concrete piles. It is important to pay attention to the economic considerations of the reconstruction, as managers of lower category roads often only have a rather limited budget.

The crossing comprising the subject-matter of this article is located on the Bzura River in the town of Klewków, Łowicz commune. Before replacement, the static system of the structure comprised four simply supported bays. The load-bearing structure of the bridge consisted of four girders made of rolled steel I-beams, braced using rolled channel cross beams. The outermost supports (abutments) were made as massive reinforced concrete structures, while the intermediate ones were made as spatial timber pile supports. The timber bridge suppor

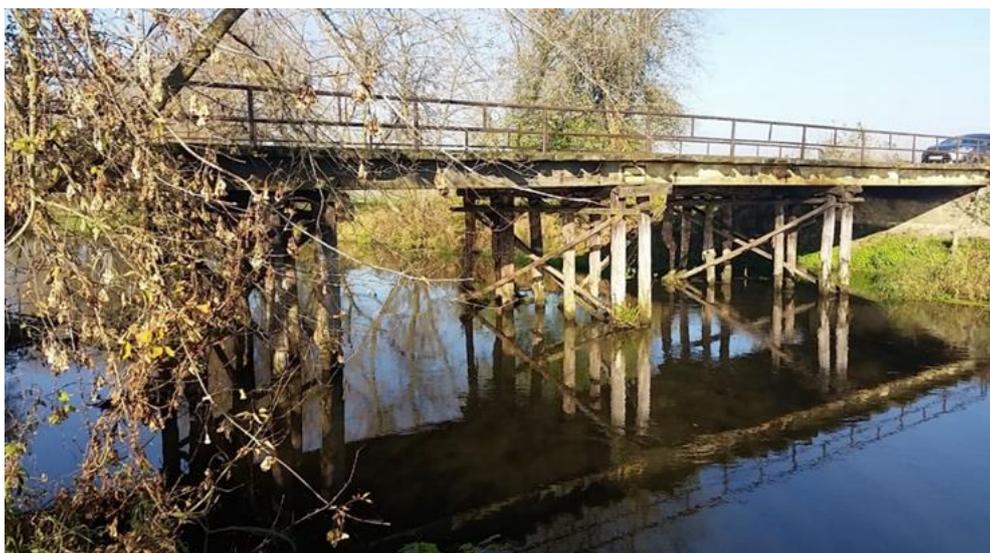
Fig. 1. View of the crossing over the Bzura river in Klewków before modernisation (author's work).

In the first place, a detailed technical condition assessment, consisting of an analysis of the load bearing structure and support system was carried out for the existing low-level structure. According to the said assessment, the bank supports, and intermediate supports were defective, the supports did not have adequate load bearing capacity and spatial rigidity. The bridge support system had to be completely replaced, which also involved rebuilding of the span structure.

Given the extent of the required repair works, a decision to build a new bridge was made. A proposal was put forward to build the bridge in a three-span continuous beam system, with a steel-concrete composite span structure. The support system was designed in the form of prefabricated reinforced concrete piles.

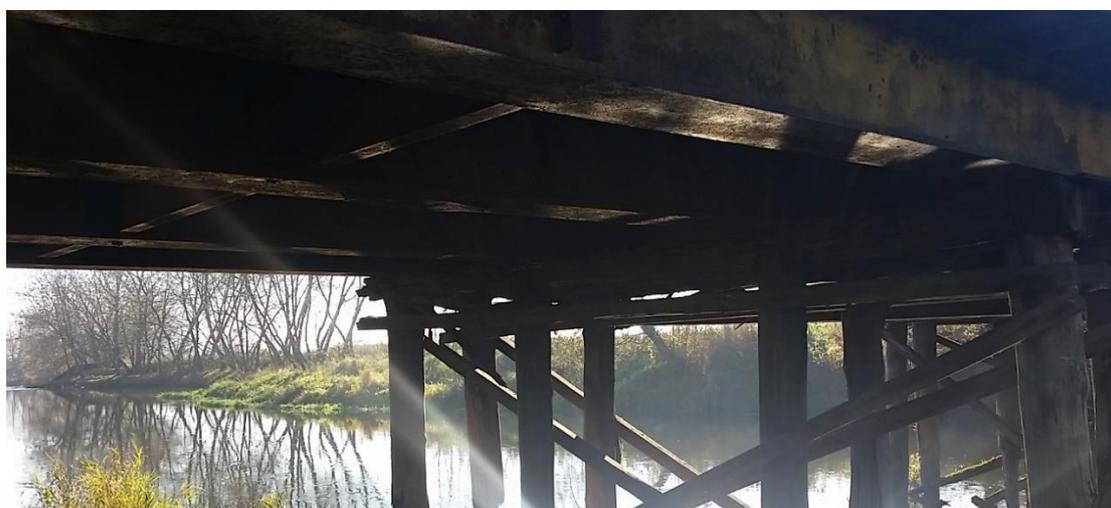
Cross beams were used to brace the main girders of the structure to each other. Their condition could be described as satisfactory, i.e., the identified damage only reduced the aesthetics (localised general corrosion) but did not cause a reduction to operating parameters. A view of the steel bridge structure is shown in Figure 2.

Fig. 2. View of the steel bridge structure (author's work).

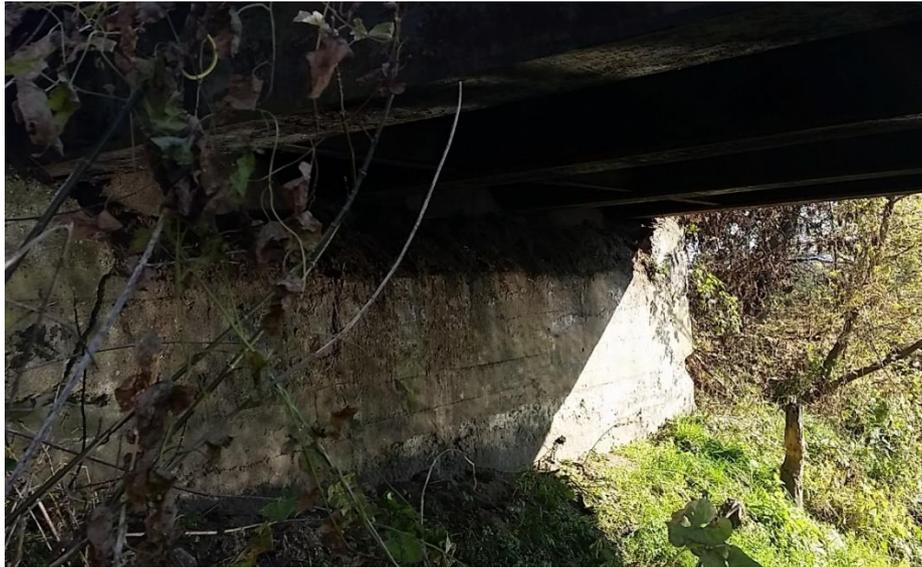
A lot of damage reducing load-bearing capacity could be observed on the massive abutments of the structure in question. The most noteworthy damage included diagonal cracks running across a considerable section of the abutment body, testifying to the poor condition and improper operation of the foundations. In addition, there was significant loss of material and thin vertical cracks indicative of reinforcement corrosion. An example of the condition of one of the bank supports is shown in Figure 3. In general, the technical condition of the abutments has been described as precarious.

Fig. 3. View of the damage to the reinforced concrete wall of the abutment (author's work).

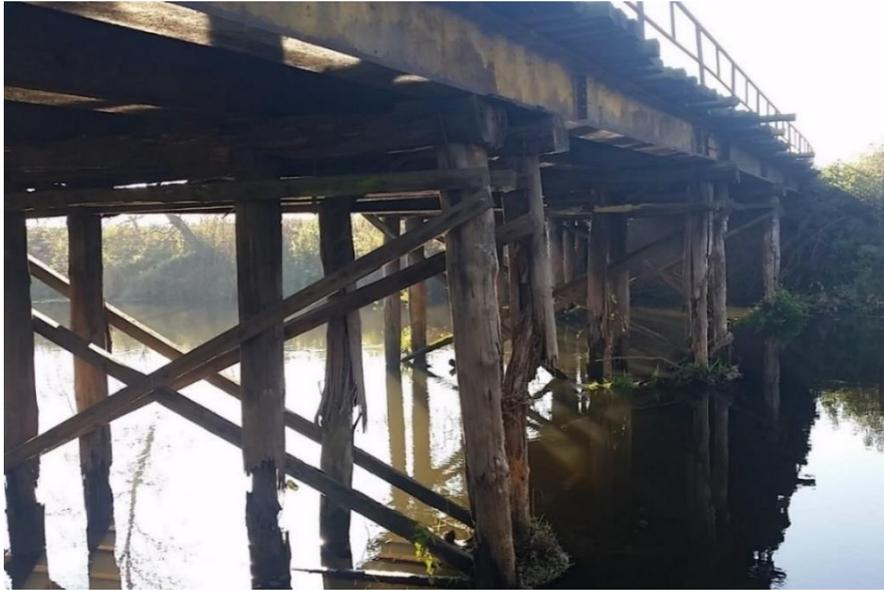
The spatial intermediate supports were in the worst technical condition out of all the bridge elements. They were assessed to be defective, which led to the structure being taken out of use. The supports made of timber piles had corrosion damage to the extent that they were almost completely destroyed - Figure 4. In many instances, the piles suffered buckling due to large cavities, which clearly reduced pile diameters thus reducing their load bearing capacity. The greatest damage occurred at the fluctuating water table level. This damage, together with the poor condition of the timber, it meant that their load-bearing capacity was reduced to almost nothing.

Fig. 4. View of the damage to the intermediate supports (author's work).

Pursuant to an assessment of bank and intermediate supports, carried out in accordance with the bridge assessment system (tab.1) set forth in the "*Instruction for carrying out inspections of road engineering structures, Appendix to Resolution No. 14 of the General Director of National Roads and Motorways of 7 July 2005*" [2], the structure was determined to be defective. A solution entailing a complete replacement of the bridge structure with a new one with a load-bearing capacity in line with today's standards was proposed.

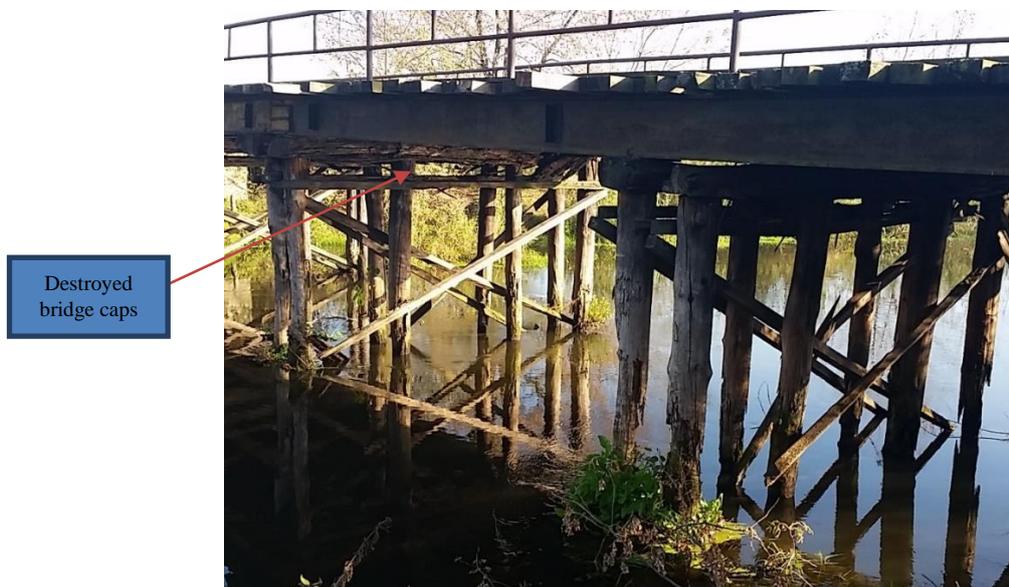
Fig. 5 shows the extensive damage to the timber bridge caps and the horizontal and diagonal bracing of the intermediate supports. As the steel superstructure of the bridge is supported by the bridge caps, such extensive damage (decay, rot and cavities) has resulted in a virtually complete loss of load bearing capacity, both in terms of compression and bending. Pile bracing was broken and had large cavities, and in this condition the bracing did not fulfil its role of providing stiffness to the supports.

Fig. 5. View of the damage to intermediate support braces (author's work).
