Cause-and-effect analysis of unusual audible sounds in a roof truss structure of a multi-family residential building. A case study.

The aim of this paper is to present a cause-and-effect analysis of unusual audible sounds in the roof truss structure of a multi-family residential building as a case study based on a technical survey carried

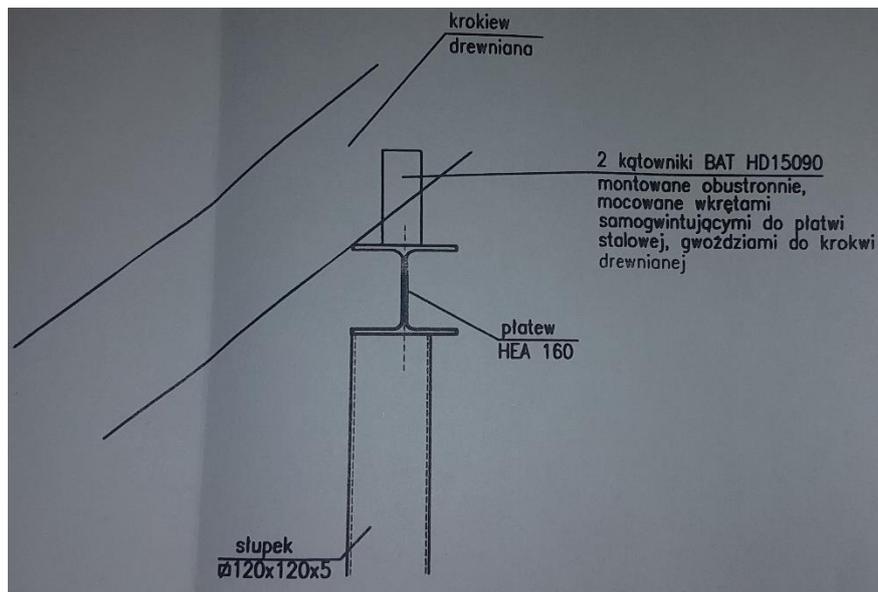
Fig. 2. Element of the connection between a timber rafter and a HEA 160 purlin using two BAT HD15090 angles according to the as-built documentation [7].

- II) A drawing showing connection elements of the roof truss structure is included in the as-built documentation for the steel roof trusses of the building (Fig. 2). This detailed drawing shows an element of the connection between a timber rafter and a HEA 160 steel purlin using two BAT HD15090 angles attached to both surfaces, with self-tapping screws to the steel purlin and nails to the timber rafter. Therefore, the as-built documentation indicates that construction elements made of different building materials, i.e., steel and wood, were joined together. The site visit also confirmed these elements were joined directly at roof truss structure connection points (Fig. 5a-b). Such direct “rigid” joining (without the use of elastomer spacers for example) of elements of building materials characterised by different thermal expansion may lead to inconveniences in the operation of the roof truss structure described as audible “crackling”.

- dismantle and scrap the roof covering made of coated steel sheet panels;
- install damping in roof framing structure connection points, i.e., between structural elements made of different building materials such as, steel and timber, by using elastomer spacers to eliminate direct contact between wood and steel for example;
- add narrow planks to the existing roof battens with aim to create a partial boarding;
- re-lay roof covering using new standing seam coated steel panels;
- apply additional soundproofing tape (membrane) fixed to the planks under the centre of each steel roof panel to reduce noise.

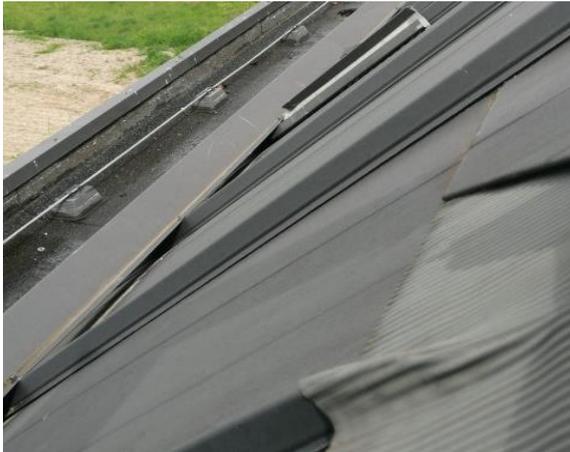
Fig. 3a. Roof covering – standing seam coated steel roof panel [7].

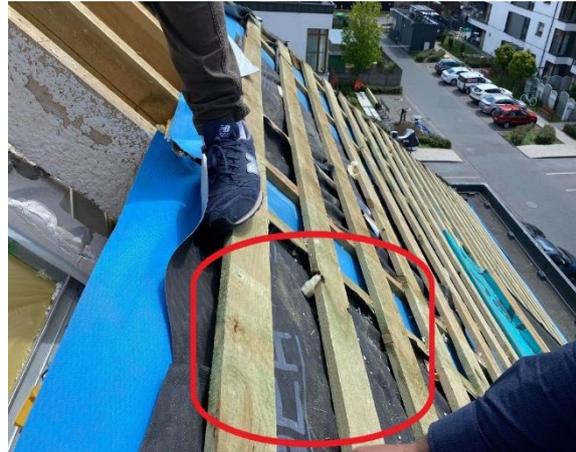
Fig. 3b. Timber battens for a coated steel roof panel (marked in red) [7].

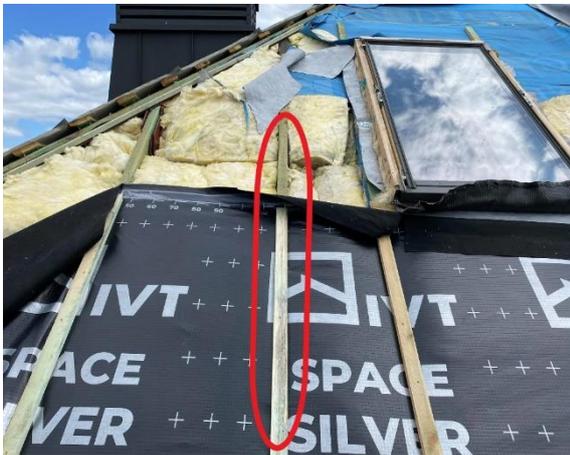
Fig. 3c. Counter battens (counter batten marked in red) and black wind resistant membrane under counter battens [7].

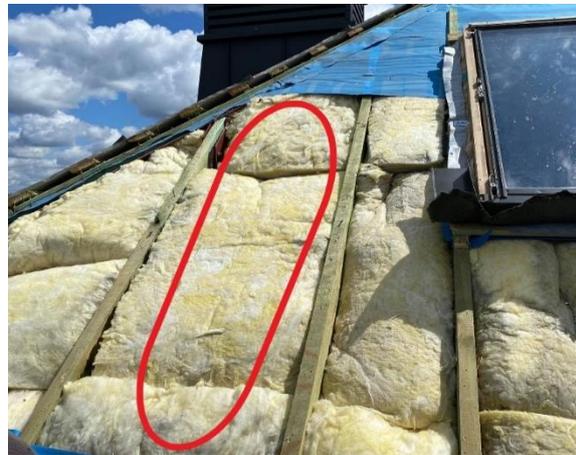
Fig. 3d. Mineral wool (marked in red) [7].

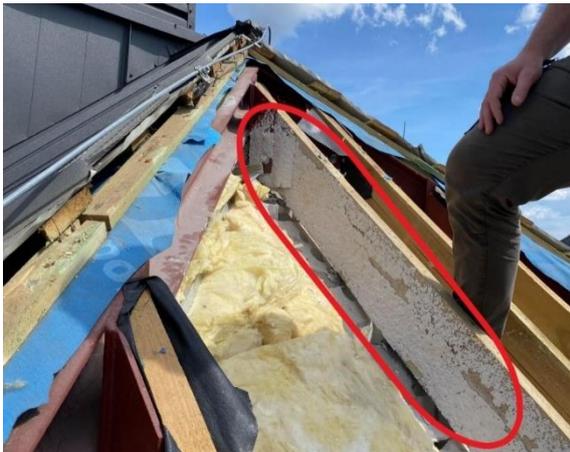
Fig. 3e. Timber roof rafter (marked in red) [7].

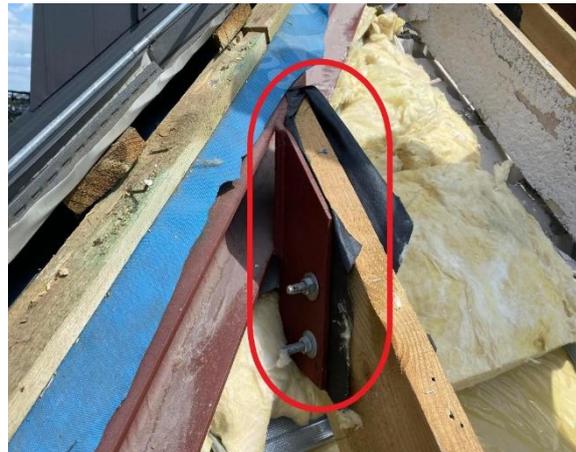
Fig. 3f. Connection point for wooden and steel elements (marked in red) of the roof truss structure. Visible damping membrane between wood and steel at this connection point [7].

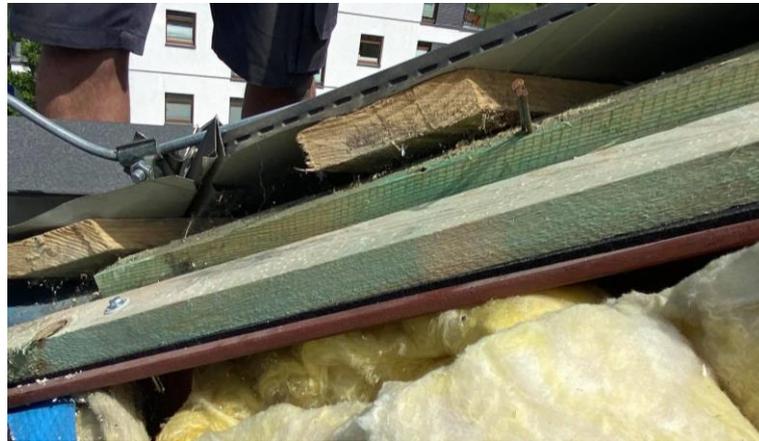
- I) Issues significant for boarding and battening for tin roofing should be emphasised here. Due to the expanding properties of non-ferrous metal sheets, full boarding is a must if these materials are used. This applies to aluminium, titanium-zinc and copper metal sheets. Partial boarding is acceptable if using standing seam metal roofing panel systems, which mainly contain iron. Fig. 4 shows battens made of timber planks instead of partial boarding under steel sheet roof panels.

Fig. 4. Use of wooden battens instead of partial boarding [7].

The adverse sounds under certain weather conditions (strong wind) were caused by direct (without spacers) and careless joining of two construction materials, wood and steel, at connection points, and the use of wooden battens instead of partial boarding.

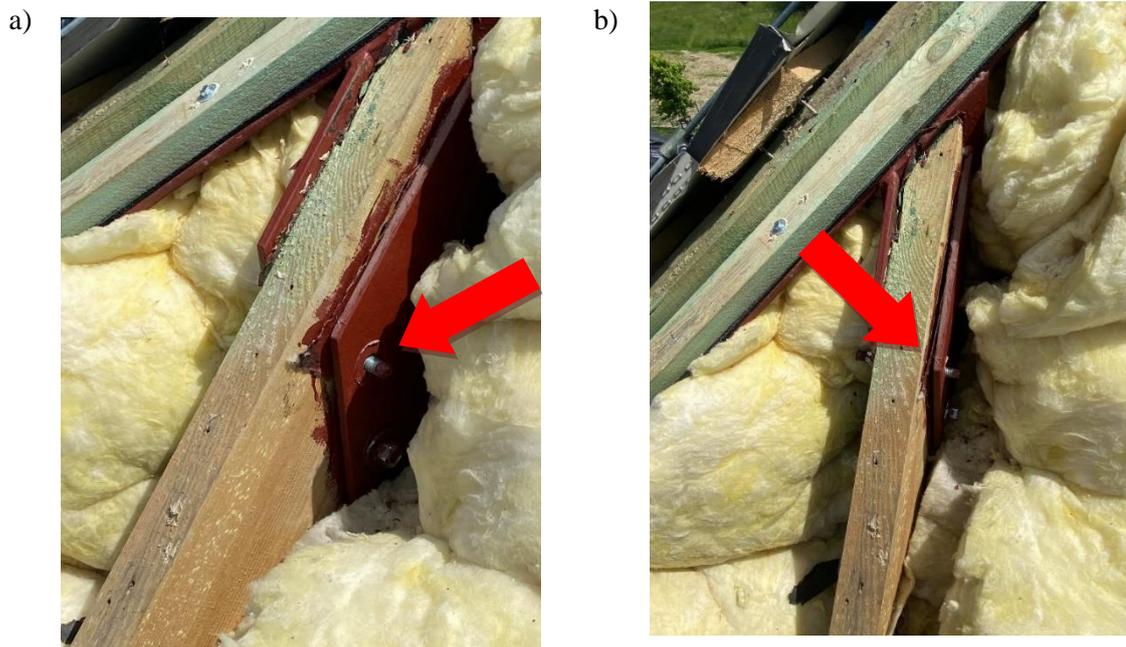
Fig. 5a-b. A solution avoiding direct contact between timber and steel at the connection point is not used. Apparent absence of nuts on bolts (indicated by red arrows) results in loose joints [7].
