## Analysis of damp in the substructure of a multi-family residential building – case study

**Abstract:** This paper discusses dampness in an underground garage of a multi-family residential building on the basis of a case study. Due to high groundwater levels, the building substructure was constructed using W8 watertight concrete. This applies to both the foundation slab and substructure walls. However, leaks have occurred even though the used solutions were in theory designed to protect the building substructure from rainwater ingress. Macroscopic in situ tests, boreholes in the garage hall floor and foundation slab as well as laboratory test to determine the watertightness of the concrete were carried out to determine the cause of this construction defect, manifesting itself as damp in the structural elements in question.

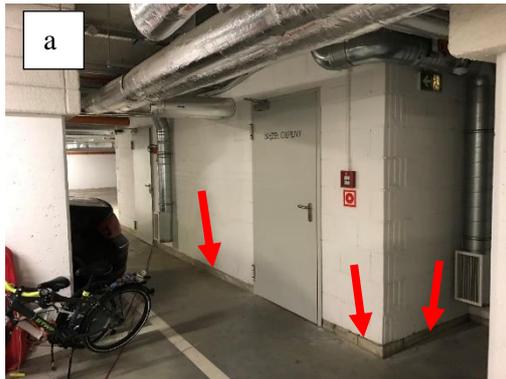
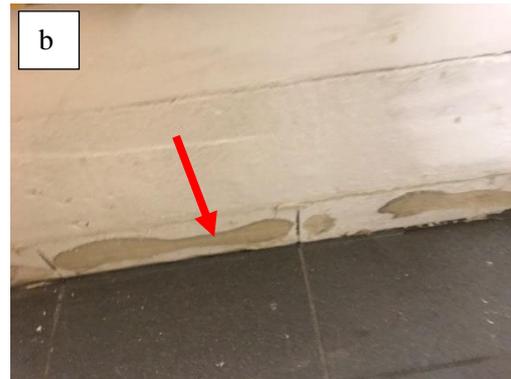
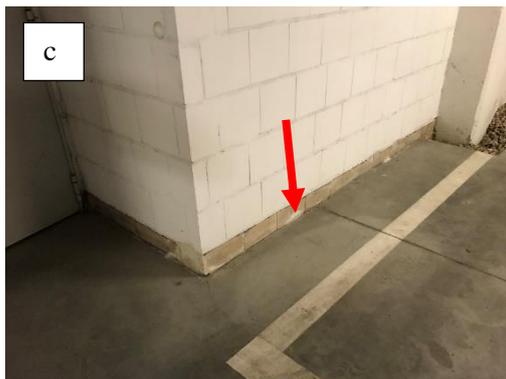
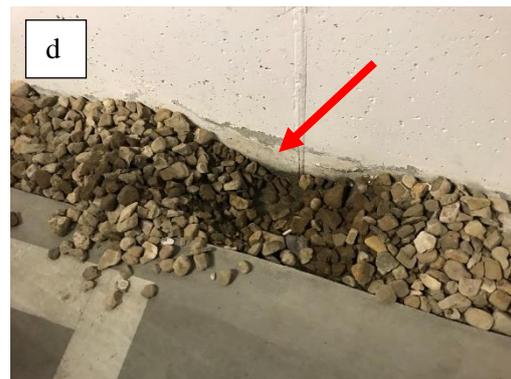
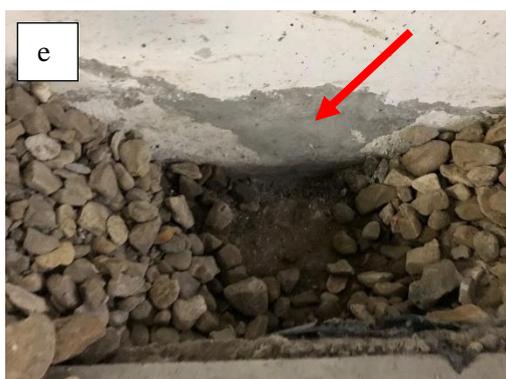
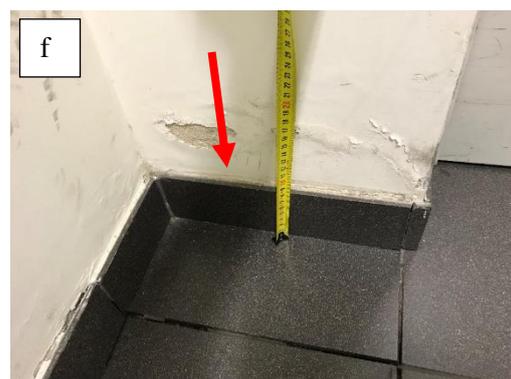
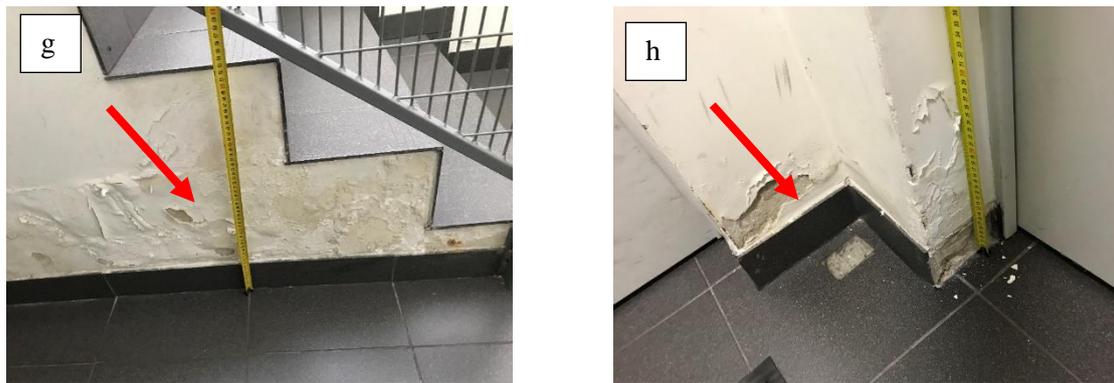
In the first place, even before the team decided to carry out a structural survey, a site visit took place. It was noted that despite the use of watertight concrete technology, known as “non-bituminous proofing”, signs of damp were visible in the building substructure. Both the garage walls and the stairwell walls were affected. Troughs filled with aggregate were constructed around the garage floor near the walls to allow groundwater to evaporate, but also to assess the presence of groundwater ingress into the building. Figures 1 a) – 1 h) show damp on the walls of the building substructure.

**Fig. 1.** Damp in the building substructure: a), b), c) walls of infrastructure rooms and resident's storage rooms; d), e) external walls of the underground garage; f), g), h) stairwell walls.

As internal walls were not damp-proofed correctly (vertical damp insulation was not slotted between the internal walls and the floor) in resident’s storage rooms, infrastructure rooms, stairwell vestibules, lift vestibules and stairwells, groundwater (which is under the floor) causes the walls in these rooms to become damp.

- thorough drying of stair runs’ side surfaces;
- gel grouting in walls of lift shaft vestibules, stairwells and stairwell vestibules as well as infrastructure rooms and resident’s storage rooms – injections should be performed as close as possible to the floor level;

- damp-proof grouting for stair runs structures – injections should be performed as close as possible to the floor level;
- layer based dpc in internal walls of lift shaft vestibules, stairwells and stairwell vestibules as well as walls of infrastructure rooms and resident’s storage rooms;

- reconstruct plasterwork (it is advisable to apply “breathable” restoration plasters) on the walls of stairwells, lift shaft vestibules, stairwell vestibules and the side surface of stair runs;

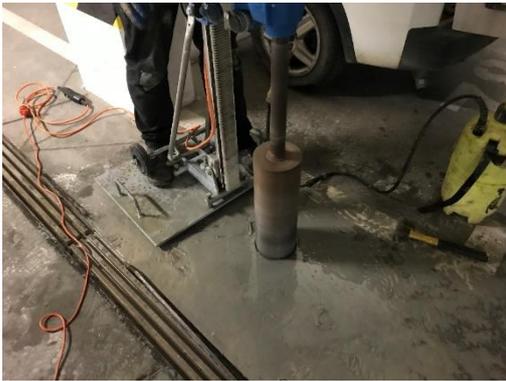
A borehole (Figure 2.1) was performed to check compliance of the constructed layers with the design and to take a sample for watertightness testing of concrete from the underground garage floor and foundation slab. The borehole made it possible to determine that the foundation slab below an approximately 10 cm thick floor (Figure 2.2 and Figure 2.3) was 27.7 cm thick (Figure 2.4 and Figure 2.5). According to the design documentation, the foundation slab should be 40–60 cm thick. At the borehole there was no separation layer (made of black construction film for example) between the floor and the foundation slab.

**Fig. 2.1.** Overall view of boreholes in the underground garage floor and foundation slab.

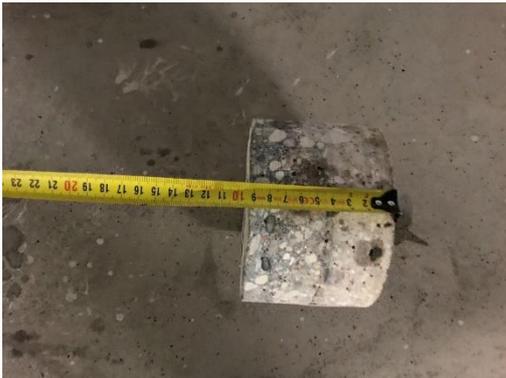
**Fig. 2.3.** Measuring the thickness of the borehole in the underground garage floor: 9.5 cm.

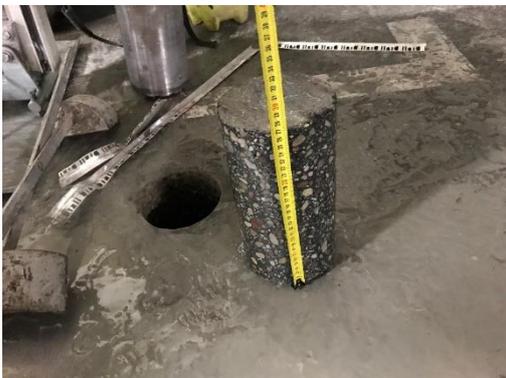
A watertightness test was carried out on a sample from a borehole (Figure 2.5) drilled into the underground garage foundation slab under laboratory conditions. As a result of the test, the watertightness class was found to be W8 and is in accordance with the as-built documentation.

**Fig. 2.5.** Measuring the thickness of the borehole in the underground garage foundation slab: 27.7 cm.

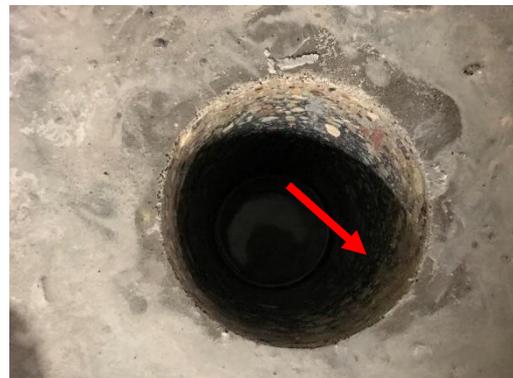
The boreholes revealed the presence of groundwater between the underground garage floor and foundation slab. It was also found that, under dynamic loads applied to the top floor surface, the water

between the floor and the foundation slab was pumped into the boreholes (Figure 2.6). The water level did not rise during the course of a 24 hours of observation.

**Fig. 2.6.** The red arrow indicates water between the floor and the foundation slab.

the foundation slab at locations marked by a blue line in Figure 3. As the surface of the gravel trough along the external walls was not damp-proofed, groundwater was able to penetrate between the underground garage floor and foundation slab. Dynamic (generated by vehicle wheels) and thermal loads on the floor displaced the groundwater located between the underground garage floor and foundation slab.

Groundwater is also present between the underground garage floor and foundation slab. Complete drying of the garage foundation slab would require the floor layer to be removed which is not economically feasible. Thus, despite the implementation of the above remedial programme, localised damp in structural partitions may appear.

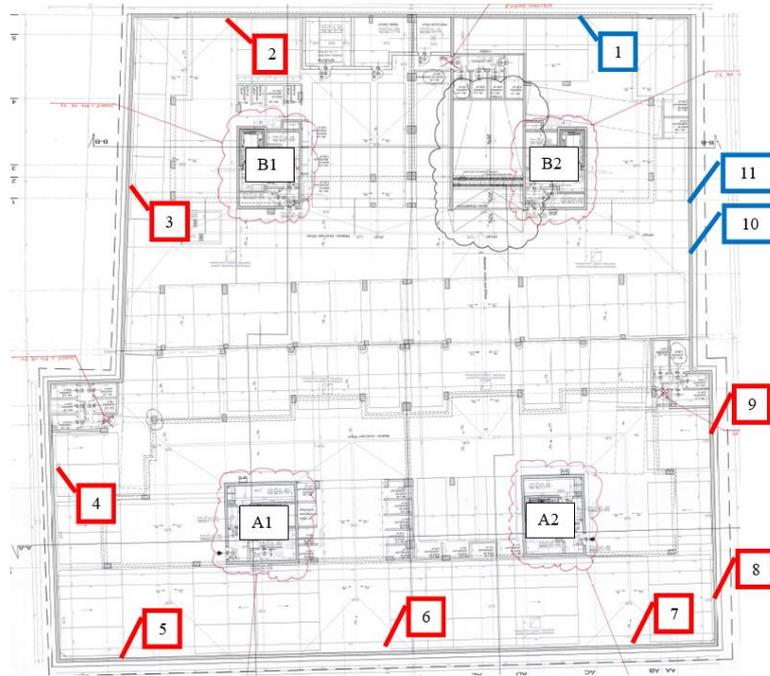
The highest moisture levels were found at measurement points 1, 10 and 11 – readings taken right by the bottom of the gravel trough. The locations of these points may indicate areas where leaks are occurring at the joint between the foundation slab and the walls.

**Fig. 3.** Locations of moisture measurement points on the underground garage external walls are shown in red and blue. Measurement points with the highest moisture levels are shown in blue. For the purposes of this study stairwells are marked with the A1, A2, B1 and B2 symbols.

The highest moisture level was found at a measurement right by the bottom of the gravel trough and is shown in blue on Figure 3. As a result of the tests and visual inspection, it should be concluded that groundwater was penetrating into the underground garage at the junction between the external wall and

- remove gravel from the trough in the floor along the internal faces of underground garage external walls;
- dry of the trough surfaces;
- perform damp-proof grouting at the joint between the underground garage external wall and foundation slab where leaks have become apparent;

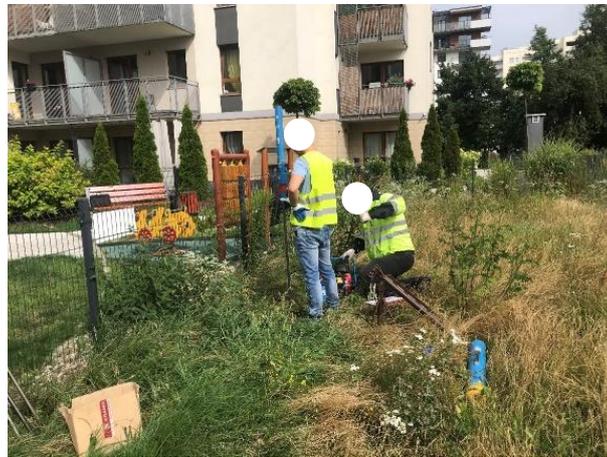
Up to a depth of 80 cm in the test soil the soil compaction index  $I_s$  was  $\geq 0.98$ , and the compaction degree  $I_D$  of  $\geq 0.55$  was determined up to a depth of 90 cm. Highly compacted, compacted and moderately compacted soils were found from a depth of 220 cm. There were no reservations as to the compaction index and compaction degree in the tested soil.

**Fig. 4.** Overall view of a DPL dynamic probing soil compaction test.

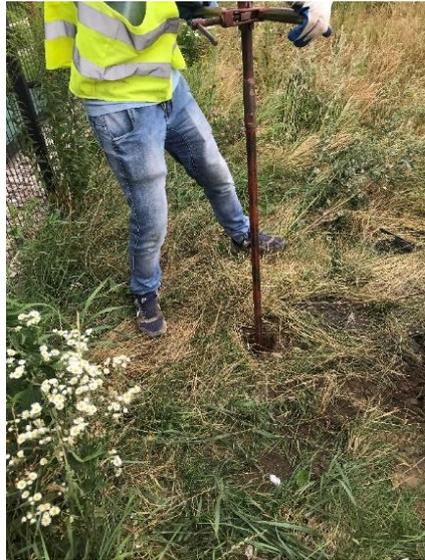
- sand-gravel mix up to a depth of 60 cm below ground level;
- loamy sand between 60 and 100 cm below ground level;
- sandy loam between 100 and 350 cm below ground level;
- groundwater level at a depth of 290 cm below ground level.

The subsurface and hydrological conditions showed no significant deviations from those described in the as-built documentation.

Fig. 5. Overall view of the soil borehole made using a hand auger.
