# ENGINEERING EXPERT RZECZOZNAWCA

## Analysis of cost-effectiveness of aircraft hangar reconstruction under new usability requirements

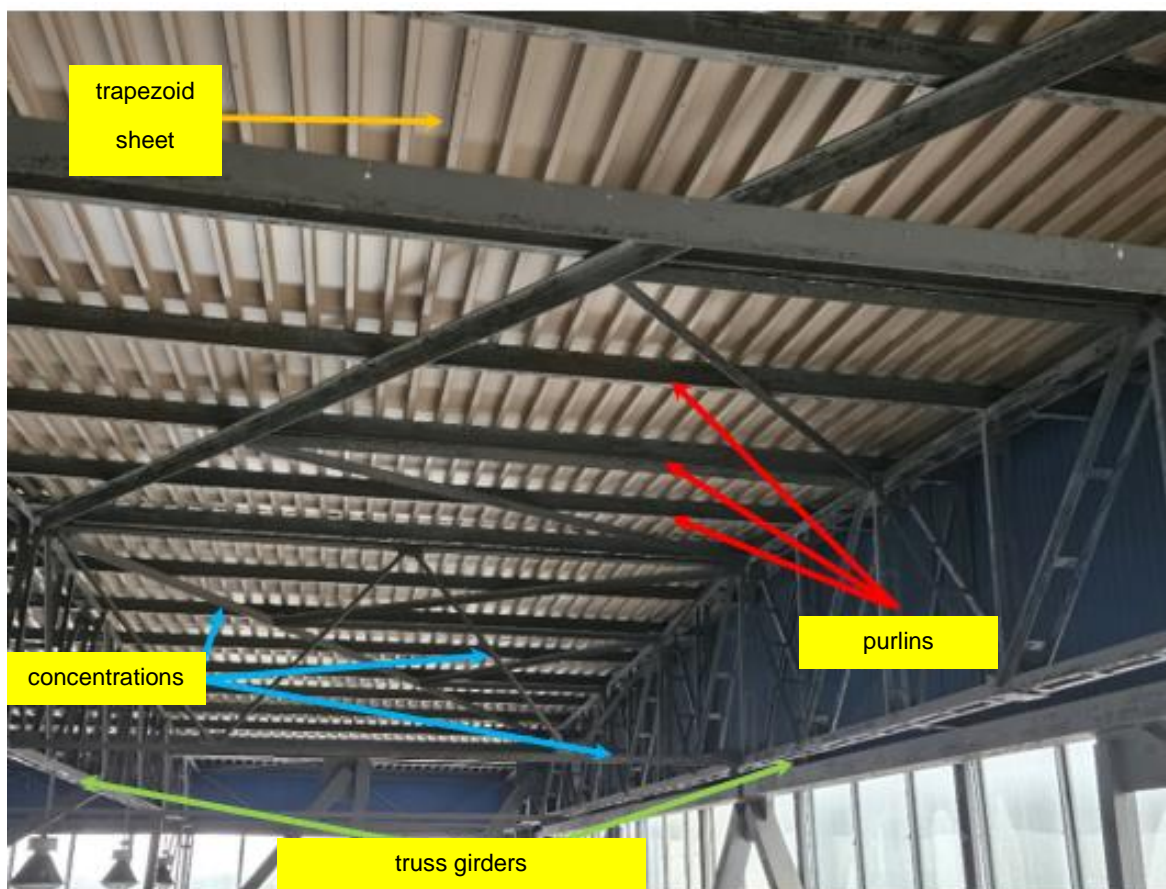
**Fig. 1.** The hangar roof structure.

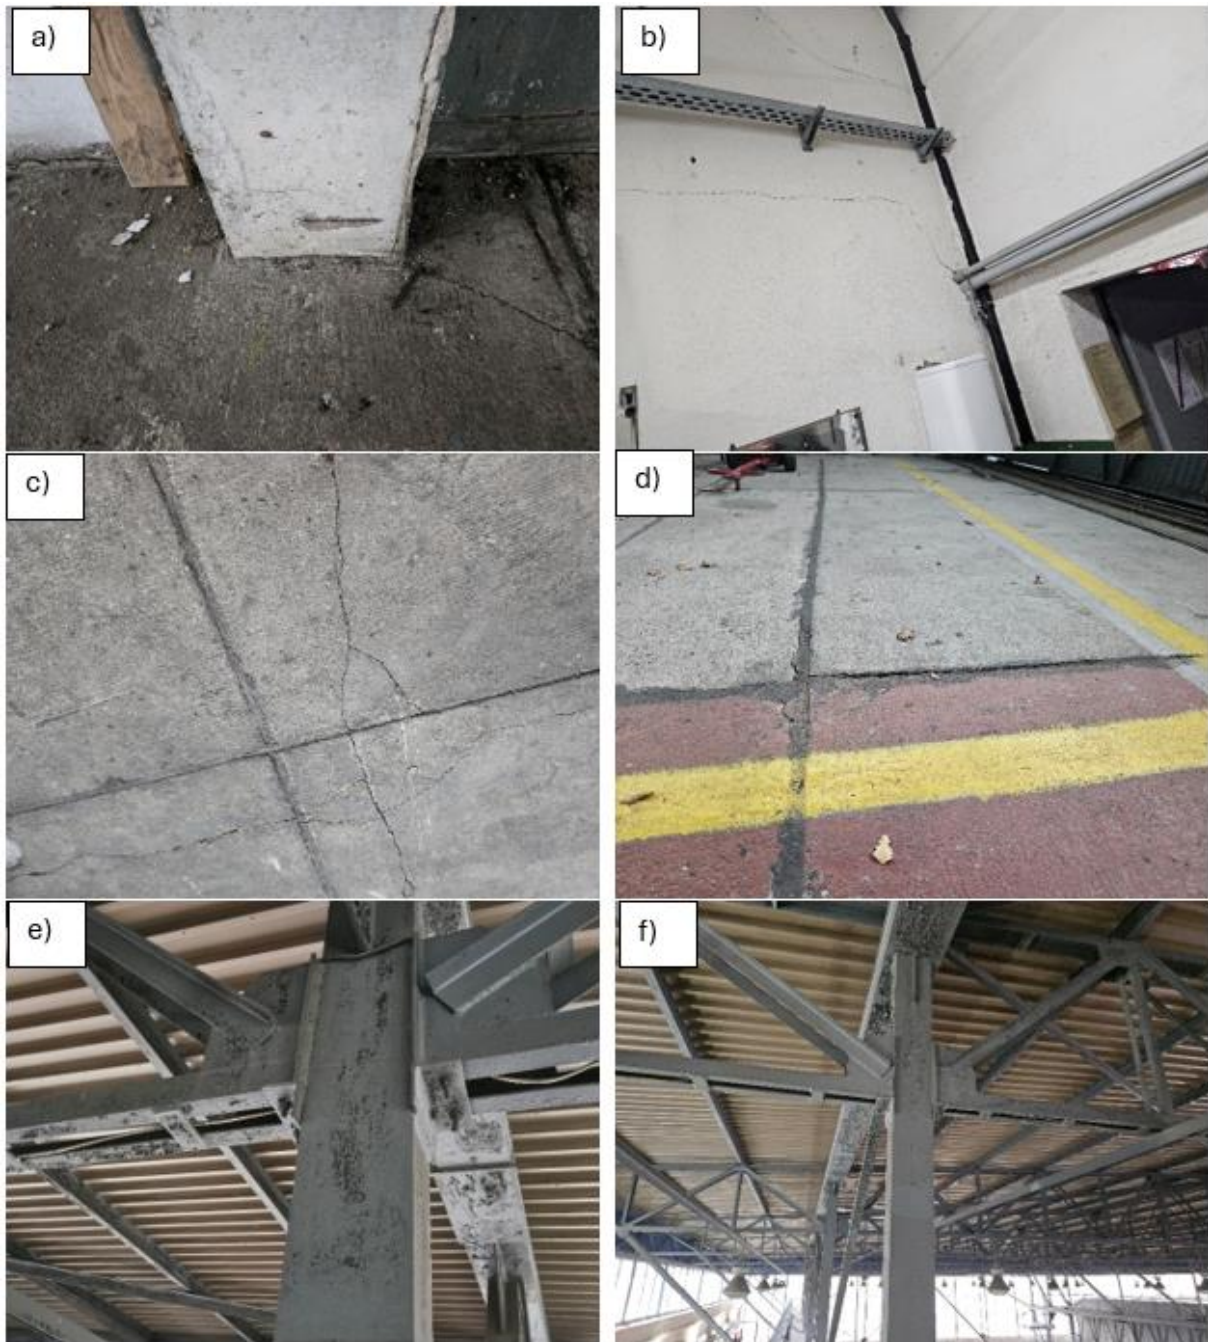
**Fig. 2.** The condition of the facility: a) damage of the column of supporting structure, b) wall cracks, c, d) condition of the hangar floor, e, f) condition of the steel roof structure.

6.	Reinforced concrete structure of extensions	Cracks in walls, cracks at the joints of prefabricated elements and fillings, local subsidence of the wall on the washed-out foundation beam, too low thickness of reinforcement lagging of prefabricates – medium condition	13,0	6,5	4,0

13.	Hangar floor	Numerous cracks, local uneven subsidence – „keyboarding” of panels, exfoliated and uneven surface – poor condition	9,5	3,42	<b>0,0</b>

- d) The reinforced concrete structure of the extensions would require repairs and reinforcements, especially in the case of single-story additions for which would be necessary to build a superstructure along with the need to replace layers of thermal insulation and roof covering due to current applicable code requirements.

- f) Due to the previously described requirements for the floor surface finish and the extent of the occurring damages, the whole floor is qualified for replacement. The costs of milling the damaged and uneven top layer, „stitching” the existitng cracks and rebuilding the milled layer with the required fusion to the new layer will exceed the costs of making a new floor. Additionally, the floors in the hangar extensions are eligible for replacement, this applies to unrenovated rooms.
