DOI: 10.37105/enex.2021.1.05

# ENGINEERING EXPERT RZECZOZNAWCA

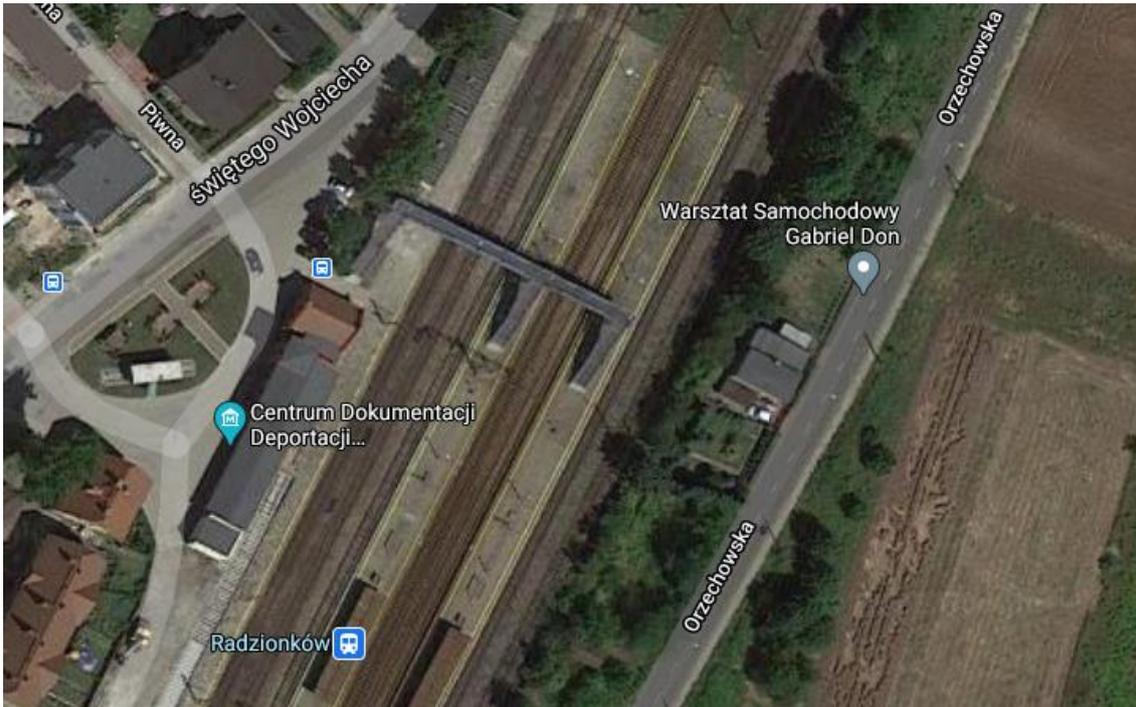
**Photograph 1.** Location of the building (source: <https://www.google.pl/maps>).

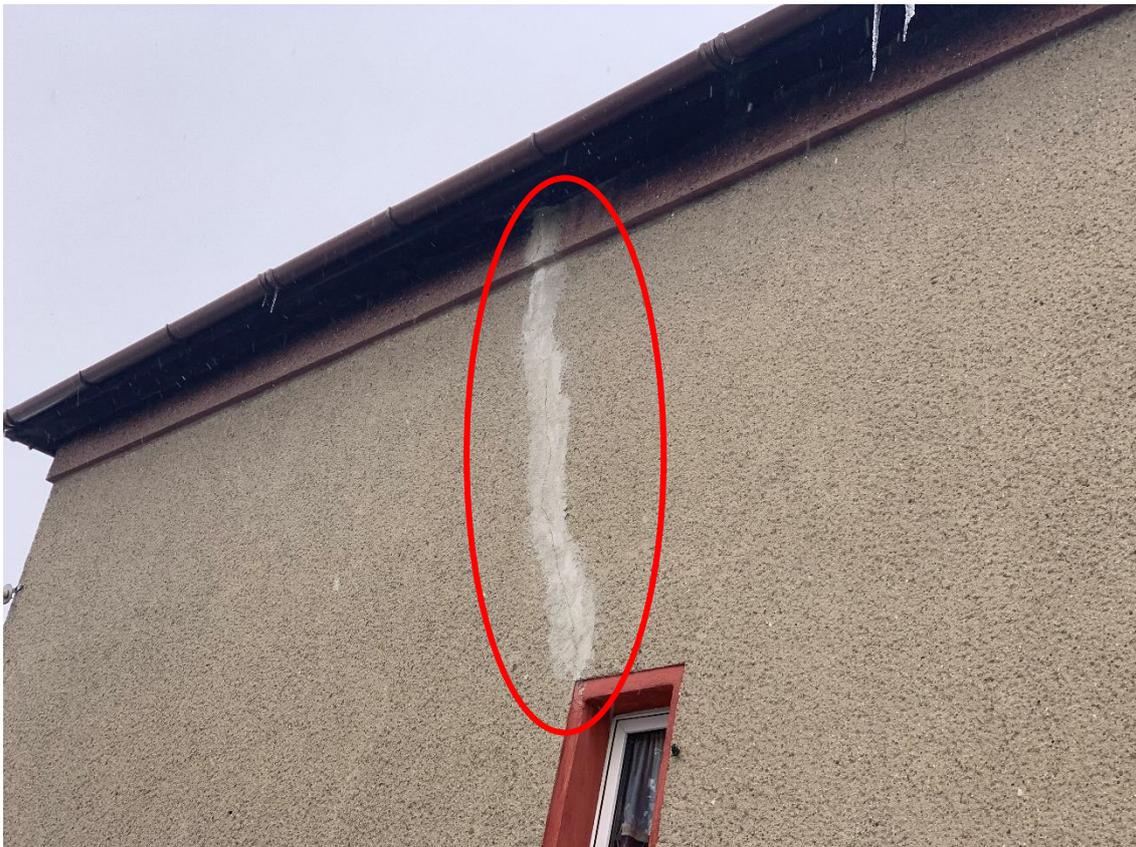
**Photograph 2.** Visible crack under repair in the façade plaster starting at the upper corner of the window opening.

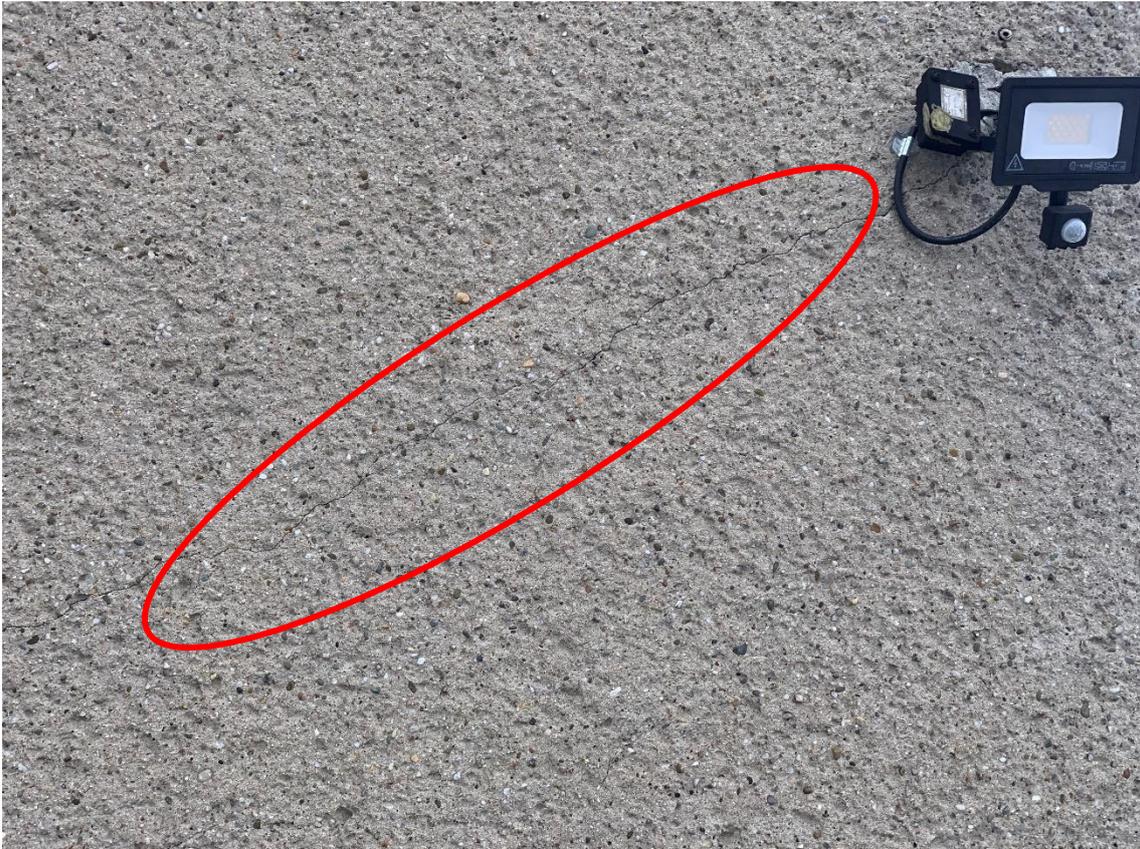
**Photograph 3.** Visible hairline diagonal crack in the façade plaster ending at a point where a lamp is attached.

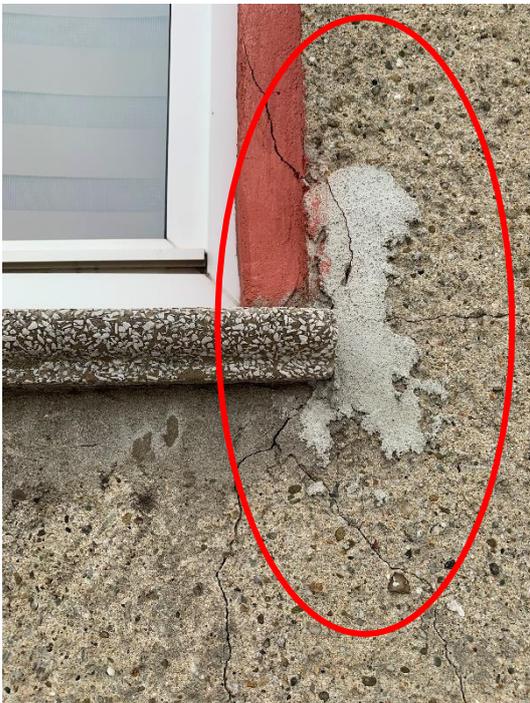
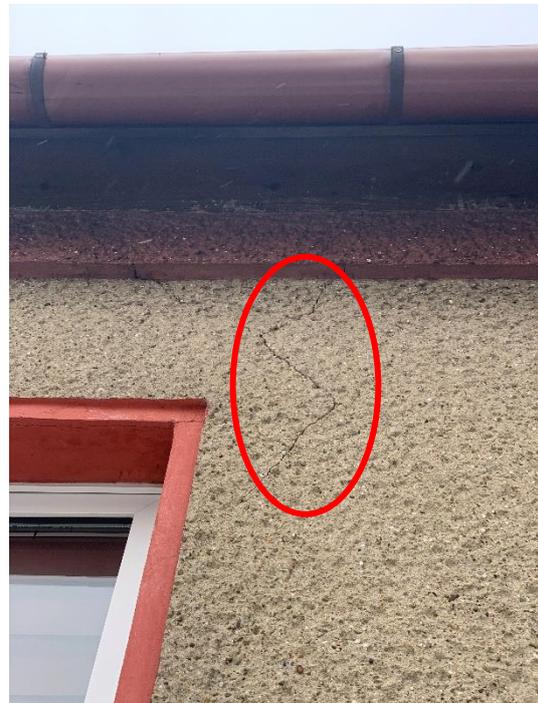
**Photograph 4.** Visible façade plaster cracks in a section where the wall is weaker due to window openings.

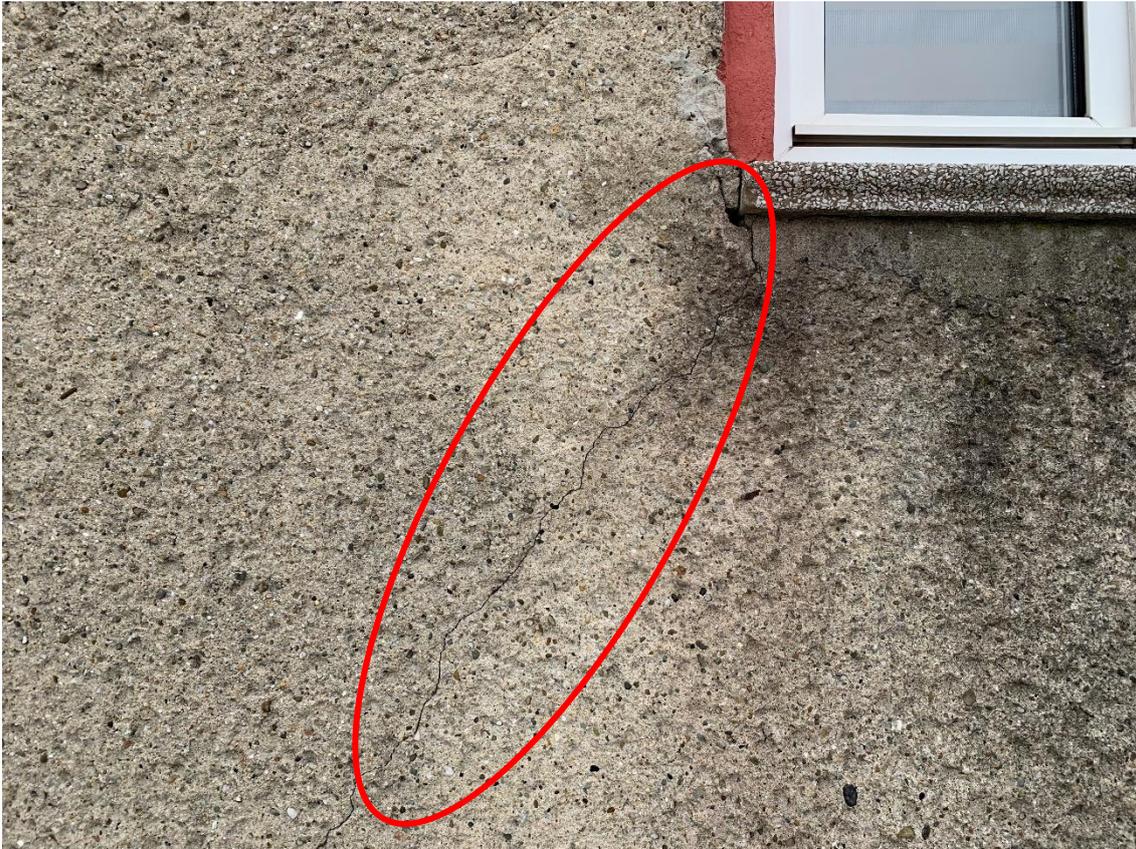
**Photograph 5.** Visible diagonal façade plaster crack in a section where the wall is weaker due to window openings.

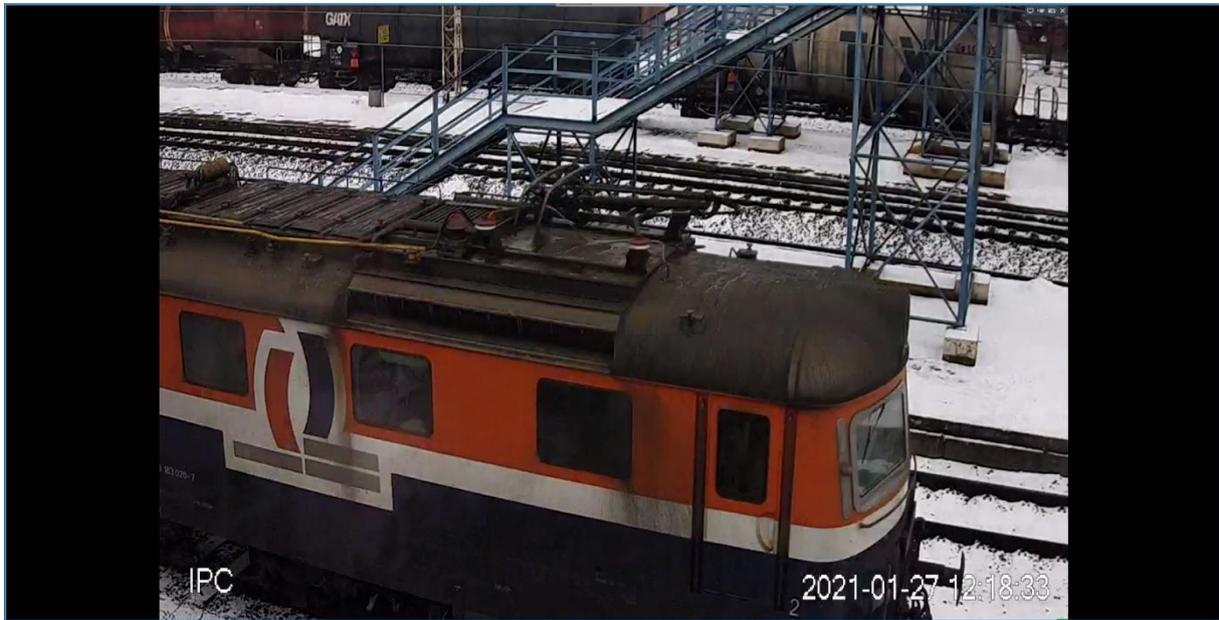
**Photograph 6.** Freeze-frame from a video recorder 12:18:33 27.01.2021.

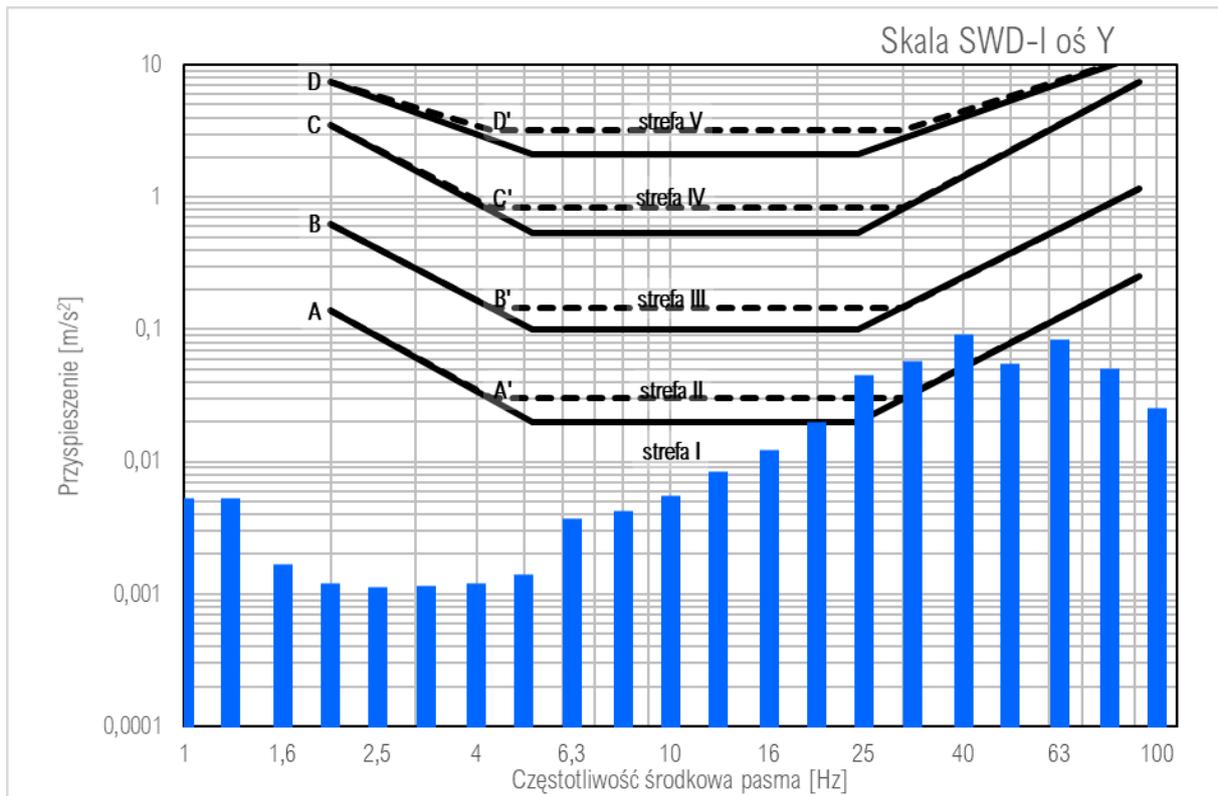
Fig. 12. Vibration acceleration measurement results along the Y axis, SWD-I scale – PP.2 measurement point.
