Emergency use of a floating bridge within a large urban conurbation

Abstract: The article presents an analysis of the use of a floating bridge within a large urban conurbation in an emergency situation. The analysis is associated with a failure of the system transferring sewage from left-bank Warsaw to the 'Czajka' treatment plant located on the right-bank of the Vistula River. It includes checking the load bearing capacity of a typical floating bridge structure constructed using the PP-64 pontoon system supporting two pipelines transporting sewage across a wide water obstacle.

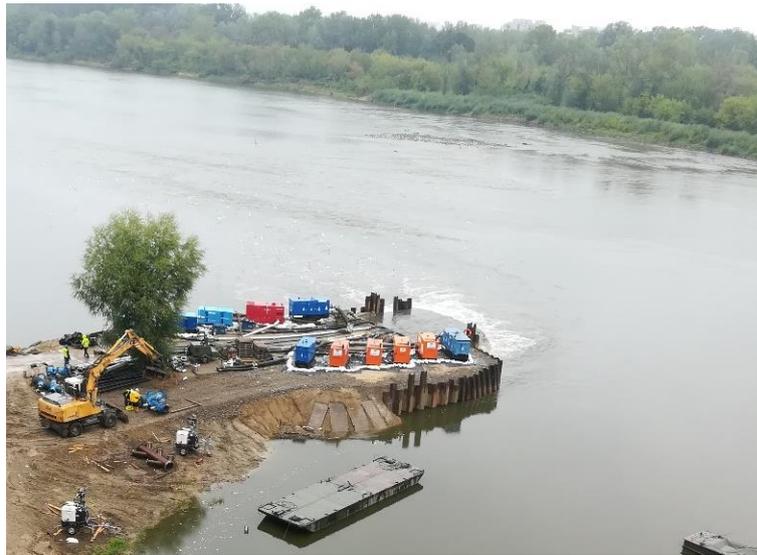
Fig. 1. Sewage discharge site on the Vistula River [own photograph].

The article presents an analysis of using a PP-64 pontoon system floating bridge, part of the assets of the Polish Armed Forces, in an emergency associated with a failure of the system transferring sewage from left-bank Warsaw to the 'Czajka' treatment plant located on the right-bank of the Vistula River. Initially, on 27 August 2019 the main transmission pipe suffered a breakdown and wastewater was re-routed to a backup transmission pipe. Unfortunately, within 24 hours that transmission pipe also broke down, as a result of which sewage was being dumped into the Vistula River. In order to minimise the consequences of polluting the river, wastewater ozone treatment began. However, approximately 260 thousand cubic metres of sewage was discharged in a day. Such a situation required a temporary sewage transfer system to be put in place. The government emergency team made a decision to build a bridge that would be used as an emergency system to transport sewage across the Vistula River. Fig. 1 below depicts the sewage discharge site. A steel collector tank constructed out of steel sheet piles can also be seen, together with pumps in place to receive wastewater.

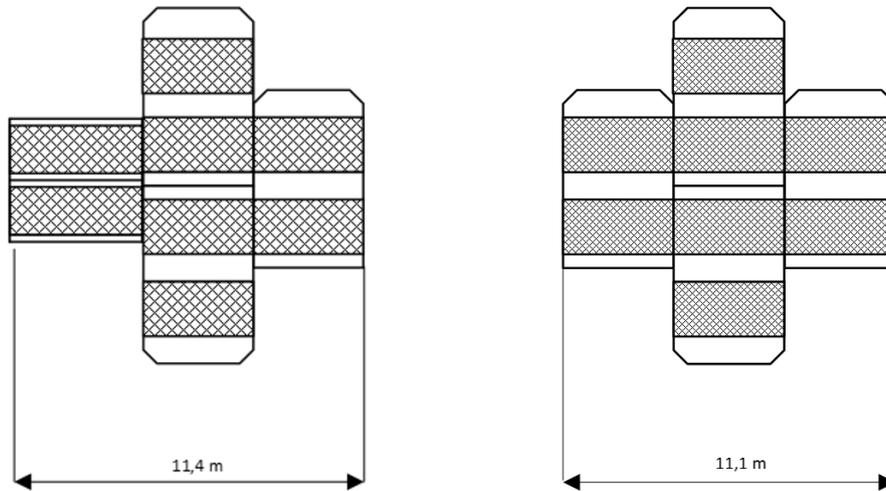
A PP-64 system set comprises 48 floating units mounted on Star 266 AP-64 vehicles, 6 complete shore units on STAR 266 BP-64 vehicles, 6 KH-200 bridging boats, and 6 dropside trucks for towing boats carrying ramps and other equipment. A 'C' type lane was used to perform set calculations. In a bridge of this type, every third bridge segment is made up of two floating units. Fig. 2a shows a shore

section of the bridge, whilst a river section is shown in Fig. 2b a shore section comprises three floating units and 1 shore unit; it is 11.4 m long ($2 \times 3.7 \text{ m} + 4.0 \text{ m}$). A river section comprises 4 floating units; it is 11.1 m long ($3 \times 3.7 \text{ m}$).

Fig. 2. 'C' type floating bridge elements: a) shore section, b) river section.

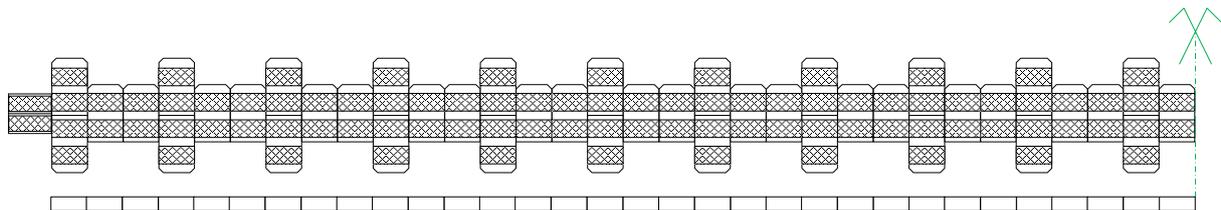
A water obstacle spanning 241.0 m requires two shore sections and twenty river sections. The total length of the floating bridge was 244.8 m. 86 floating units and 2 shore units were used. Fig. 3 depicts a diagram of half of the bridge, a fragment of the assembled bridge is shown in Fig. 4.

Fig. 3. Diagrammatic representation of half of a 'C' type floating bridge.

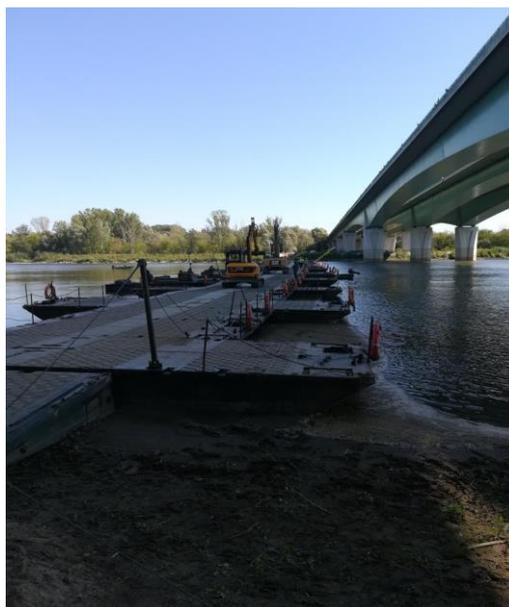
Fig. 4. A fragment of the assembled bridge [own photograph].

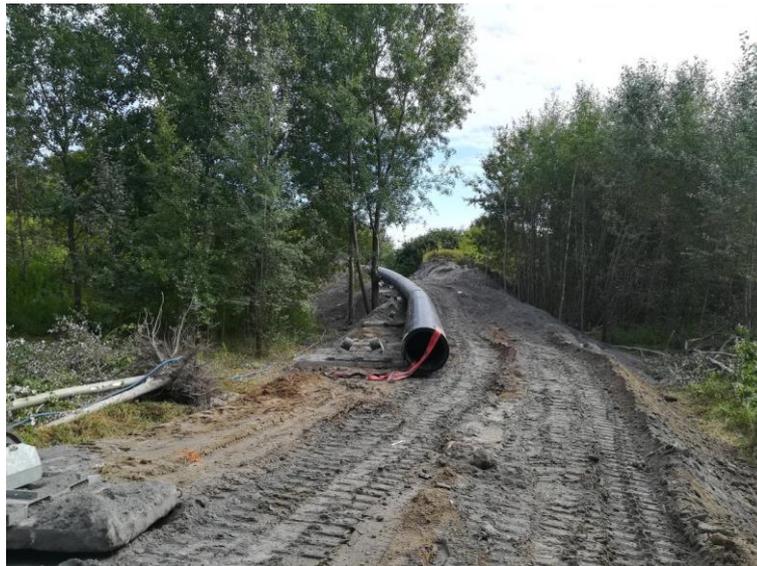
The next stage entailed an analysis and selection of a method to lay the pipelines on the bridge. As there was an urgent need to start pumping wastewater quickly, the pipeline contractor originally proposed a method involving laying one pipeline and then the other alongside the already laid pipes (Fig. 5).

Fig. 5. Lining-up a single pipeline on the shore [own photograph].

Laying the pipelines using this method was not feasible on account of the bridge use and organisational limitation. The first problem was the highly eccentric load, which required anchor

tensioners to be adjusted, posing a direct risk to the stability of the crossing. The second problem was associated with the lack of space for machinery laying the second pipeline over the crossing. Another problem was discovered on the shore while bringing the pipeline to the bridge crossing: heavy equipment pulling pipes would rise and temporarily transfer loads with only part of its tracks. This was unacceptable. In conjunction with the above, army representatives outlined a concept entailing laying two pipelines simultaneously (Fig. 6).

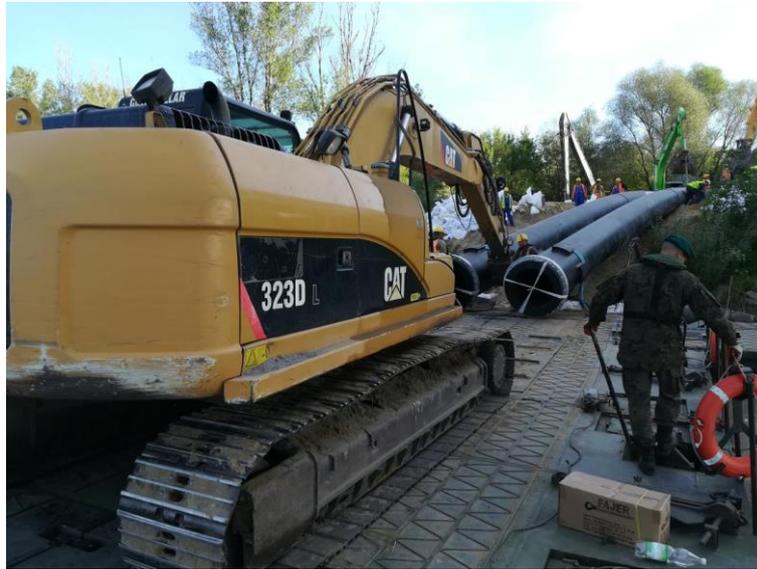
Fig. 6. Laying two pipelines simultaneously [own photograph].

Laying pipes onto the bridge was done in ‘steps’. A heavy excavator (30 Mg) moving along the bridge axis lifted and then inserted the pipes in approximately 5.0 m sections. At the same time, an excavator on the shore would push the pipelines together. Special rollers mounted on every double unit were used to lay the pipelines on the bridge (Fig. 7).

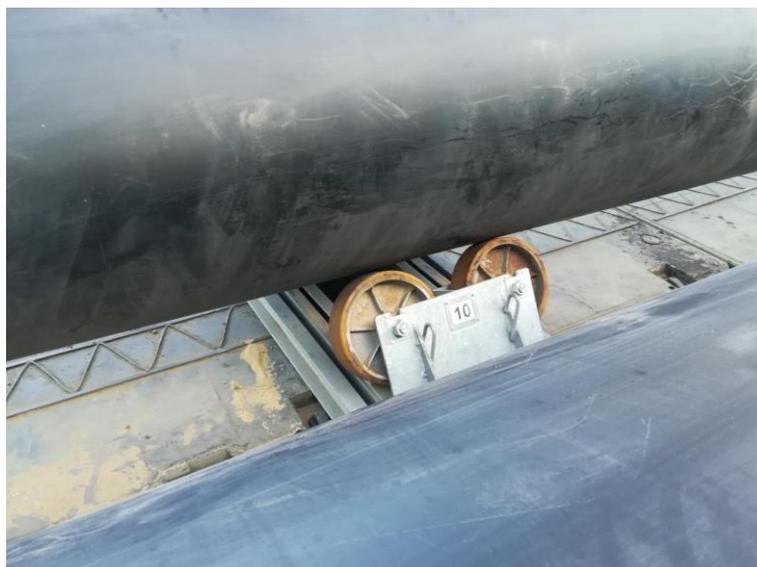
Fig. 7. Rollers for laying the pipelines on the bridge [own photograph].

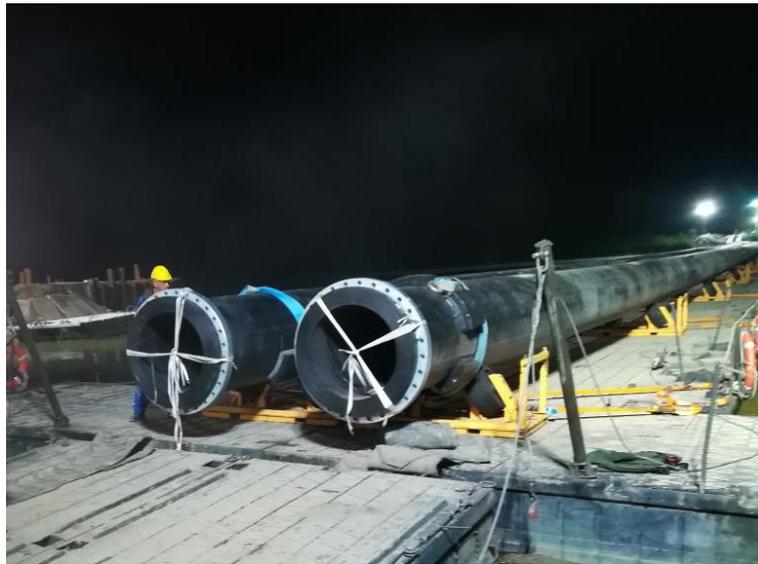
Fig. 8. Joined pipelines [own photograph].

Once the pipelines were laid along the bridge (Fig. 8), appropriate supports were put in place on each individual pontoon (timber board wedging) (Fig. 9). Fig. 10 depicts the pipelines laid along the entire bridge.

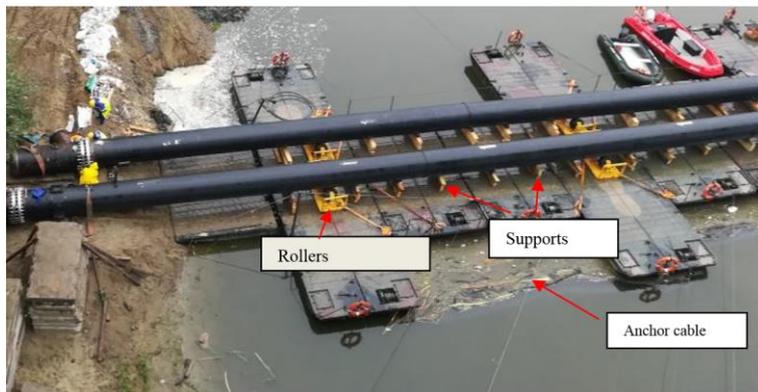
Fig. 9. Pipelines laid on rollers and supports [own photograph].

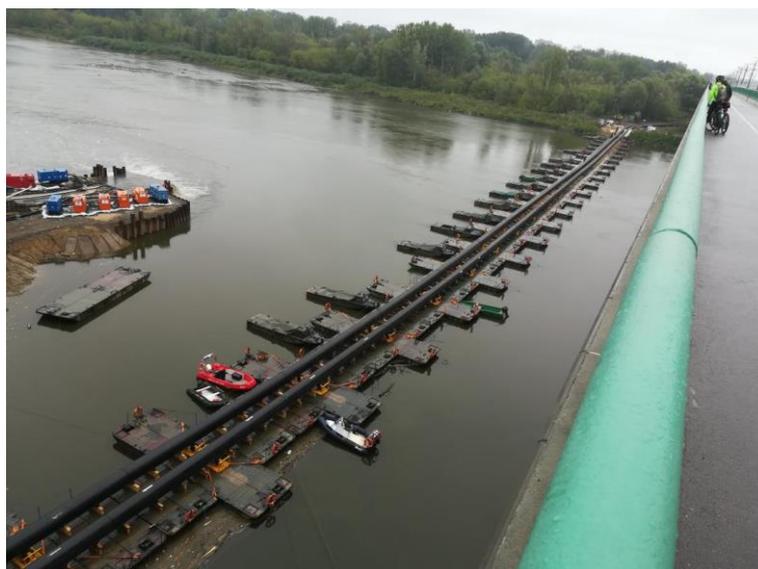
Fig. 10. View of both pipelines laid along the entire bridge [own photograph].

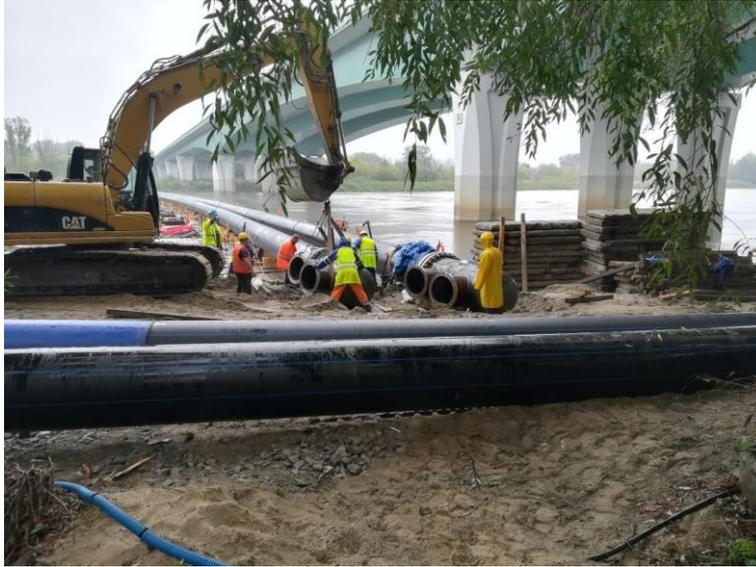
Once the pipelines had been laid along the bridge, steel inlet pipes were connected to the pumps. Two pipelines transporting wastewater from the discharge site were connected to each pipeline on the bridge (Fig. 11).

Fig. 11. Works on connecting inlet pipes to the pipelines on the bridge [own photograph].

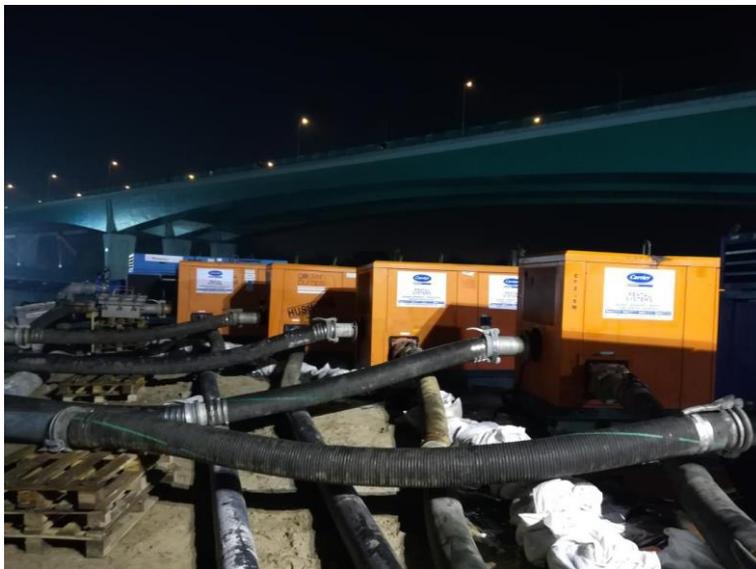
Pipelines transporting sewage from the discharge site were connected directly to a bank of pumps (Fig. 12).

Fig. 12. Wastewater feed pumps at discharge site [own photograph].

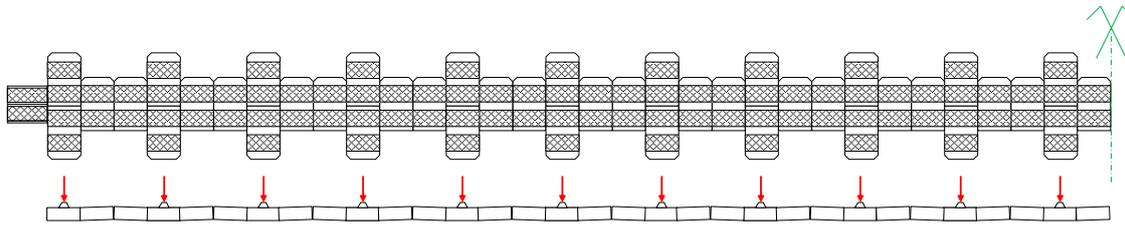
Once the pipelines had been laid on the bridge, a permanent load comprising their weight was transferred to the bridge (double units) through rollers (Fig. 13). This constituted 33% of the working load calculated for the pipelines under full load. The average draught of the bridge increased by

Fig. 13. Diagram depicting the load on the bridge exerted by the pipelines on rollers; red arrows represent loads transferred from the pipeline to the rollers.

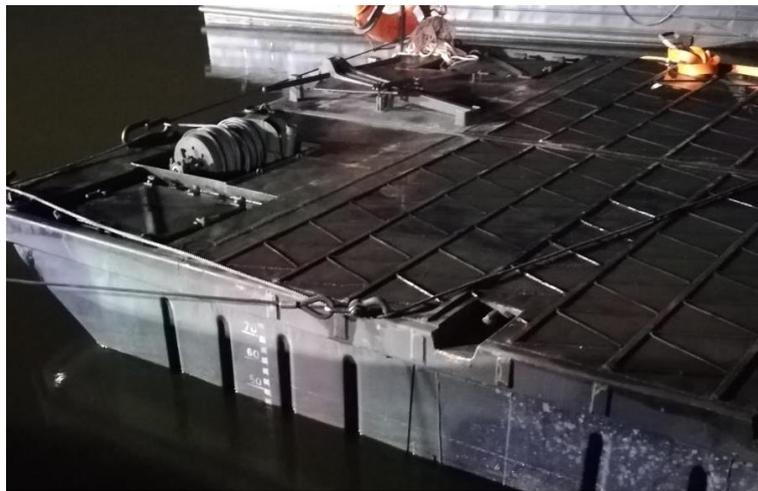
approximately 15 cm to approximately 45 cm under its own weight plus that of the pipelines (see Fig. 14).

Fig. 14. Bridge draught under pipeline load [own photograph].

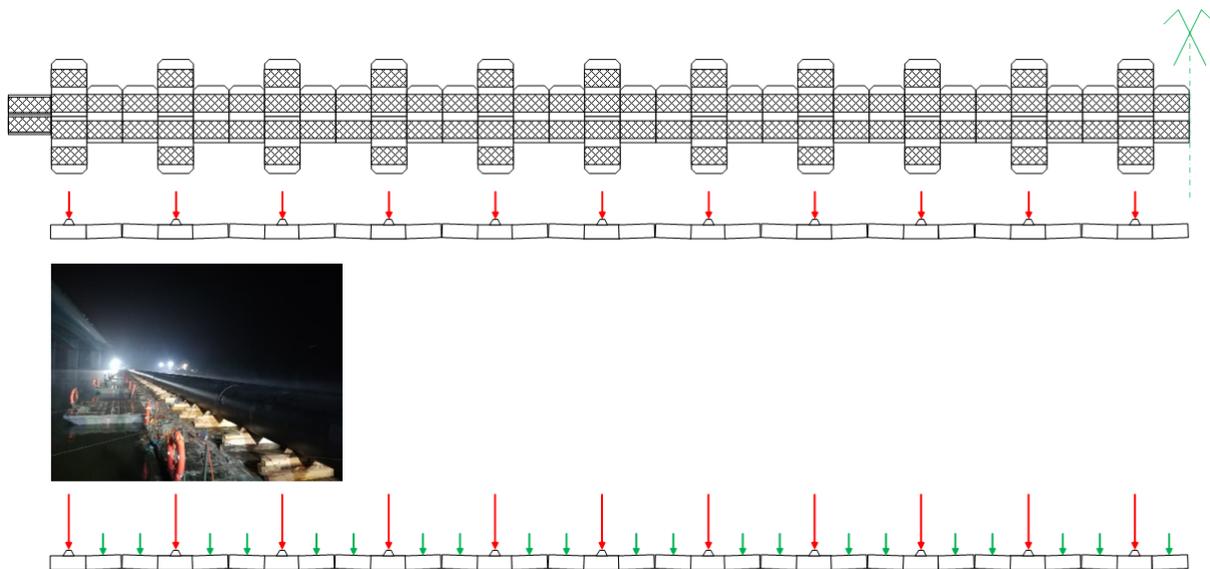
Prior to pumping sewage, as advised by the military representatives, wooden supports were placed under each pipeline (two per pontoon unit, approximately 1.85 m apart). The supports are depicted on the photograph below (Fig. 15). The support method was recommended in order to distribute the load more evenly across all the components (pontoons) so as to reduce load on the joints.

Fig. 15. View of the pipelines laid on supports; red arrows represent loads transferred from the pipelines to the rollers, while green arrows represent loads transferred by the additional wooden supports.

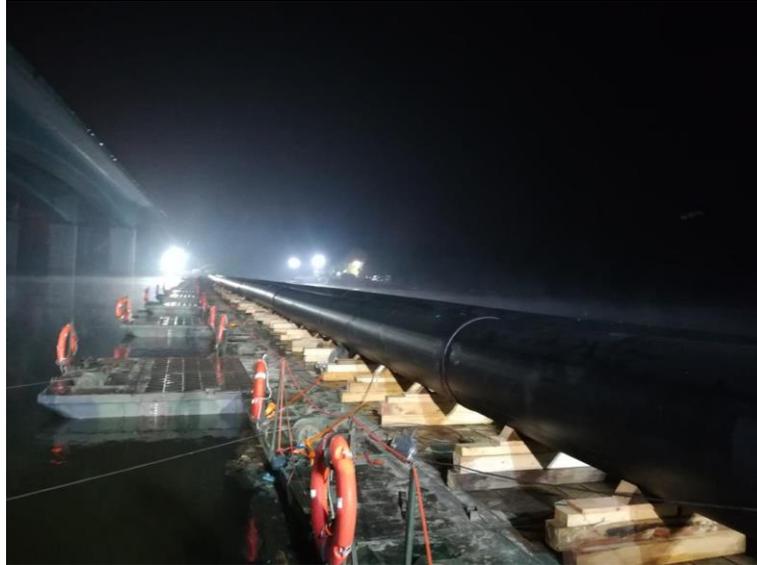
When full, the pipelines constituted 67% of the overall working load. The average draught of the bridge increased by 0.2 m. The total draught was about 65 cm; the acceptable draught for this bridge was determined to be 0.8 m [1]. This maintains a draught reserve of 0.15 m and a freeboard reserve of about 0.3 m. A view of the crossing under full load is shown in Fig. 16.

Fig. 16. The bridge under load exerted by two full pipelines [own photograph].
