DOI: 10.37105/enex.2024.1.01

Ventilated façade retrofit problems

Abstract: Ventilated facades are one of the most commonly used facade solutions. However, like any other building product, they deteriorate and become damaged over time. When the technical condition of a ventilated façade deteriorates, the building owner has to make a decision about its fate: can the ventilated façade be repaired or does it need to be demolished? This article discusses the key technical and functional factors that influence the classification of a ventilated façade for continued use, repair or demolition.

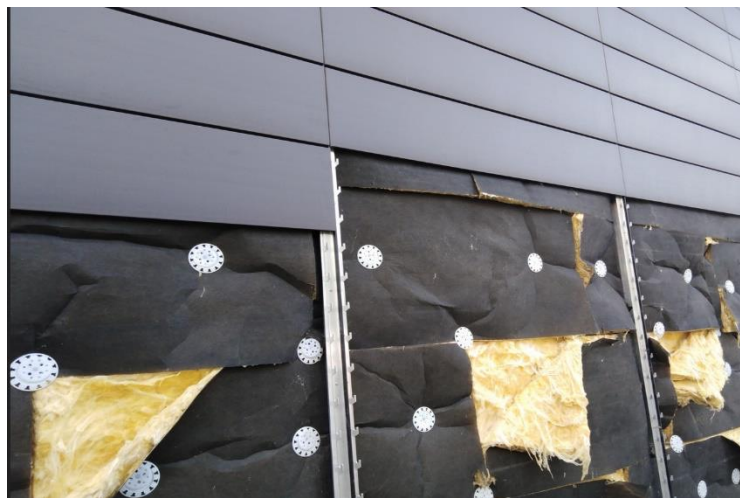
Fig. 4. Expansion of mineral wool leading to disappearance of ventilated space (Author's photo)

- reduction of the ventilated spaces between the cladding and the insulation (Figure 4),

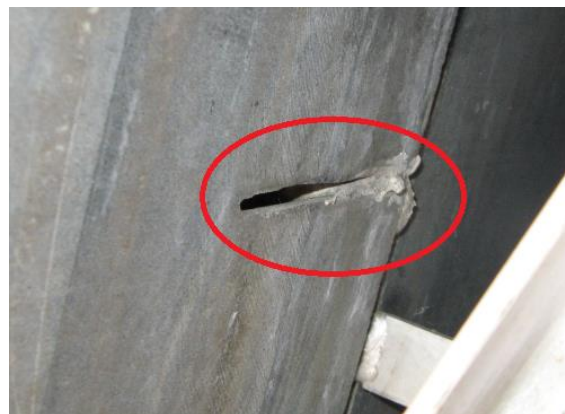
Fig. 5. Damage to "grate - elevation" connections (Author's photo)

- damage to the "grid - façade" connections (Figure 5),

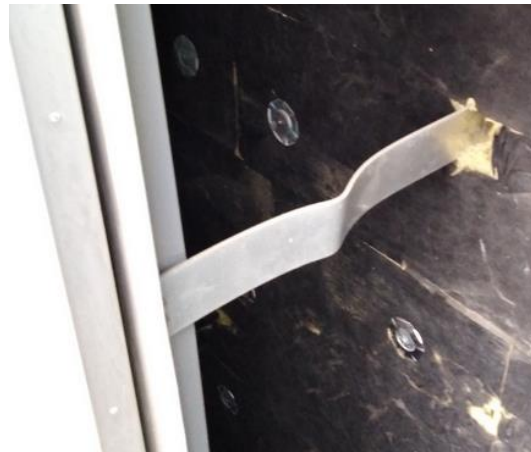
Fig. 6. Damage to the ventilated façade grid (Author's photo)

- damage to the grate (Figure 6).

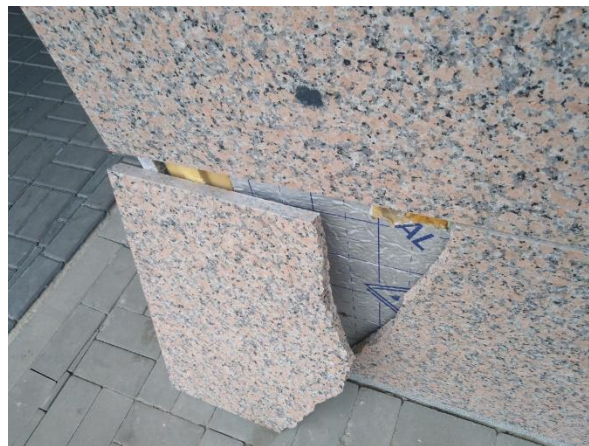
Fig. 7. Result of the impact resistance test of the ventilated façade: the façade system cannot be used in areas accessible to people (Author's photo)

Impact resistance testing can be carried out 'in situ' according to [4]. In many situations, it offers the possibility of avoiding dangerous accidents by excluding unsuitable (in terms of impact resistance) sections of ventilated façades from use (Figure 7).
