ENGINEERING EXPERT RZECZOZNAWCA

Ensuring the Safety of Buildings and Structures Damaged as a Result of Military Man-Made Actions

Gennadiy FARENYUK¹ (ORCID ID: 0000-0002-5703-3976)

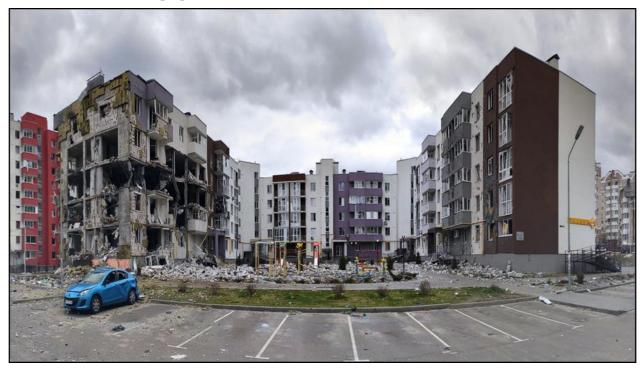
Fig. 2. View of a residential building damaged due to an aerial bomb explosion

Assessment of the technical condition of buildings damaged as a result of military operations solely using the measurement of the area of damaged structures does not allow identifying the actual properties of structures and establishing the possibility of further safe operation of the building. Figure 2 shows an example of a residential three-section building that an aerial bomb hit. The section where the bomb exploded was completely destroyed. In the other two sections all window and door external structures were knocked out, and internal structures were partially damaged. The total area of damaged structures exceeds 60%. With external inspection alone, the conclusion can be made that the building should be classified as destroyed and is subject to complete dismantling. Detailed instrumental inspections have shown that damage to structures in the undamaged sections can be eliminated by strengthening them, with the destroyed section to be dismantled and restored using a groundwork, whose structures have retained their mechanical properties.

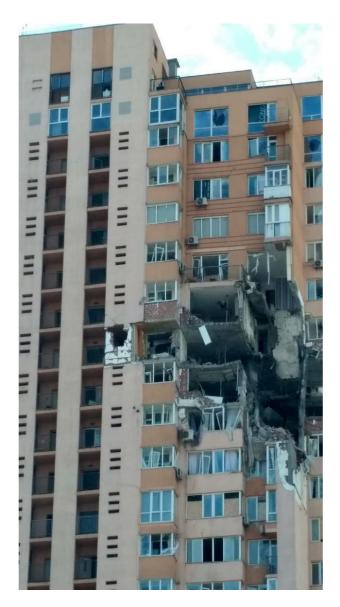
Fig. 3. View of the facade and destruction of structures after a rocket explosion

Complex engineering tasks include cases of buildings destroyed by powerful explosions inside of the buildings. Figure 3 shows a view of the building and the consequences of structural destruction from a rocket explosion on the 17th floor of a 26-storey residential building. Based on the assessment of the properties of structures on the lower floors and the construction of a mathematical model of the building as a whole [7], experts of the Research Institute of Building Constructions (NIISK) developed technological solutions for building restoration and implemented them within 3 months, which had the residents returned to their homes (Figure 4).

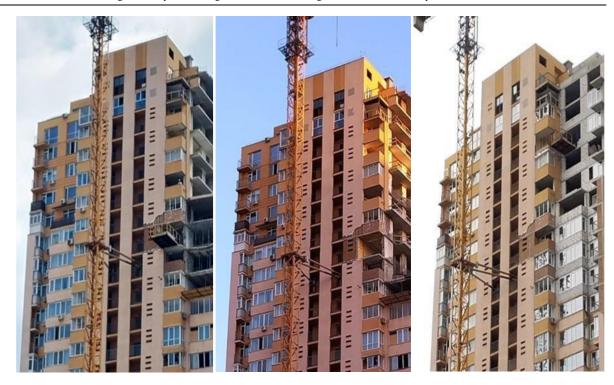
Fig. 4. View of the building that underwent restoration as of 19 August 2022, 8 September 2022, and 27 October 2022

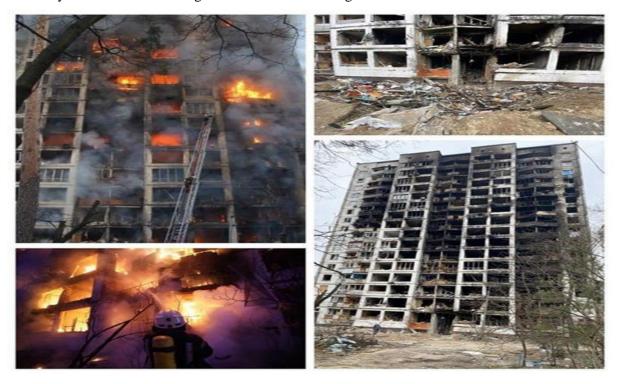
Fig. 5. Consequences of a Russian rocket hitting a residential building

Based the statistical data of NIISK's own research during 2022-2023, every third explosion in residential buildings as a result of artillery and tank shelling was followed by a fire (Figure 5), which makes it difficult to assess the technical characteristics of damaged structures. Therefore, among the challenges of ensuring safety there is the need to develop methods that cover the impact of explosions and fires caused by them when calculating structures and estimating their residual life.

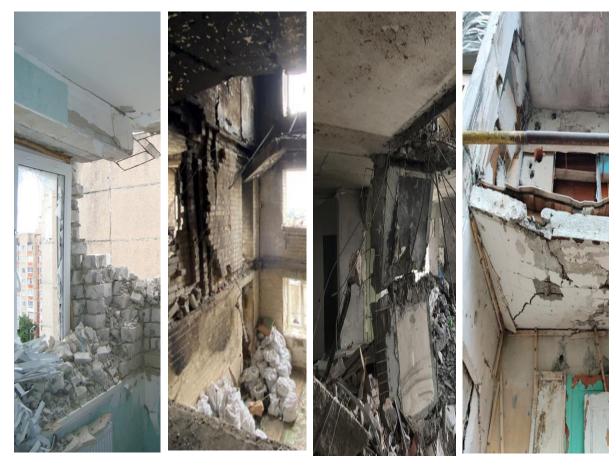
Fig. 6. Consequences of artillery shell explosions in residential buildings

The explosion is characterized by the appearance of a shock wave propagating at a high speed in the compression - rarefaction area. The wave parameters depend on the source of the explosion and the environment (air, groundwork, water), the distance to the explosion source, and other factors [8]. Blast waves impact the structure as short-term (episodic) actions that can significantly exceed the operational static loads. Construction objects are subject to requirements for the perception of dynamic load without collapse. To assess the degree of damage to buildings and structures, one should use experimental data and the results of analysis of past accidents, which facilitate identifying the degree of risk of destruction, material damage and damage to people. The results of the impact of explosions on structures are shown in Figure 6.

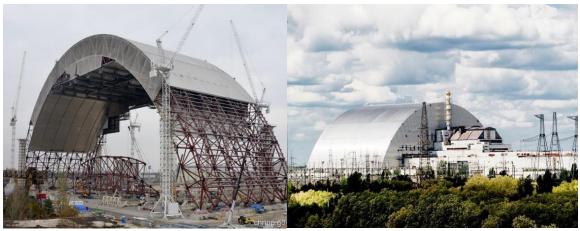
Fig. 9. Construction of the Shelter Facility in the "safe" area of the construction site and general view of the Shelter Facility after construction operations were completed

Successful experience in eliminating accidents of global significance includes the works by experts from Ukraine, the United States, France, and other European countries on creating a new Shelter Facility for the Chornobyl Nuclear Power Plant. Scientists and engineers of the Research Institute of Building Constructions provided scientific and technical support for the development, design and construction of a new confinement (Figure 8), which was put into operation in 2018. (Figure 9).

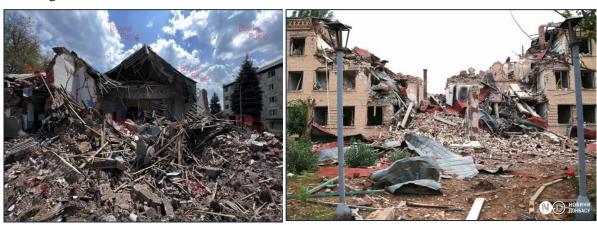
Fig. 10. Construction debris that requires recycling for secondary use

As a result of military operations in the cities of Ukraine, a huge number of construction debris have formed, which requires recycling (Figure 10). To solve this problem, modern technologies for secondary use of construction debris should be utilized, taking into account the specifics of its composition formed during the destruction of buildings, which are different mineralogy of components, different sizes of pieces, the impossibility of preliminary technological preparation, and so on. Therefore, the study of concretes based on processing should be performed and a class of structures based on them should be identified, with regulatory documentation on the field of their use to be developed. Solving these issues will necessitate combined efforts of European companies that successfully apply modern technologies for processing construction waste, and Ukrainian institutions such as the NIISK, working in the field of rationing and standardization of efficient structures.

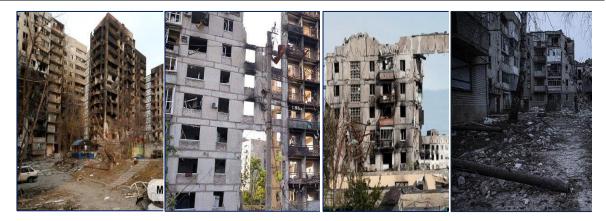
Fig. 11. Large-scale destruction of buildings in Ukrainian cities as a result of Russian shelling and bombing

The war in Ukraine has terrible consequences for the complete destruction of entire cities – Bakhmut, Soledar, and Mariupol (Figure 11). To restore these cities, the challenges of developing a concept and methodology for their new construction must be addressed.
