Determining the technical condition of steel flue gas conduit shafts' hot-dip galvanisation, illustrated with the example of chimney stacks at the 'CZAJKA' sewage treatment plant in Warsaw

Keywords: hot-dip galvanisation, chimney, Sandelin effect.

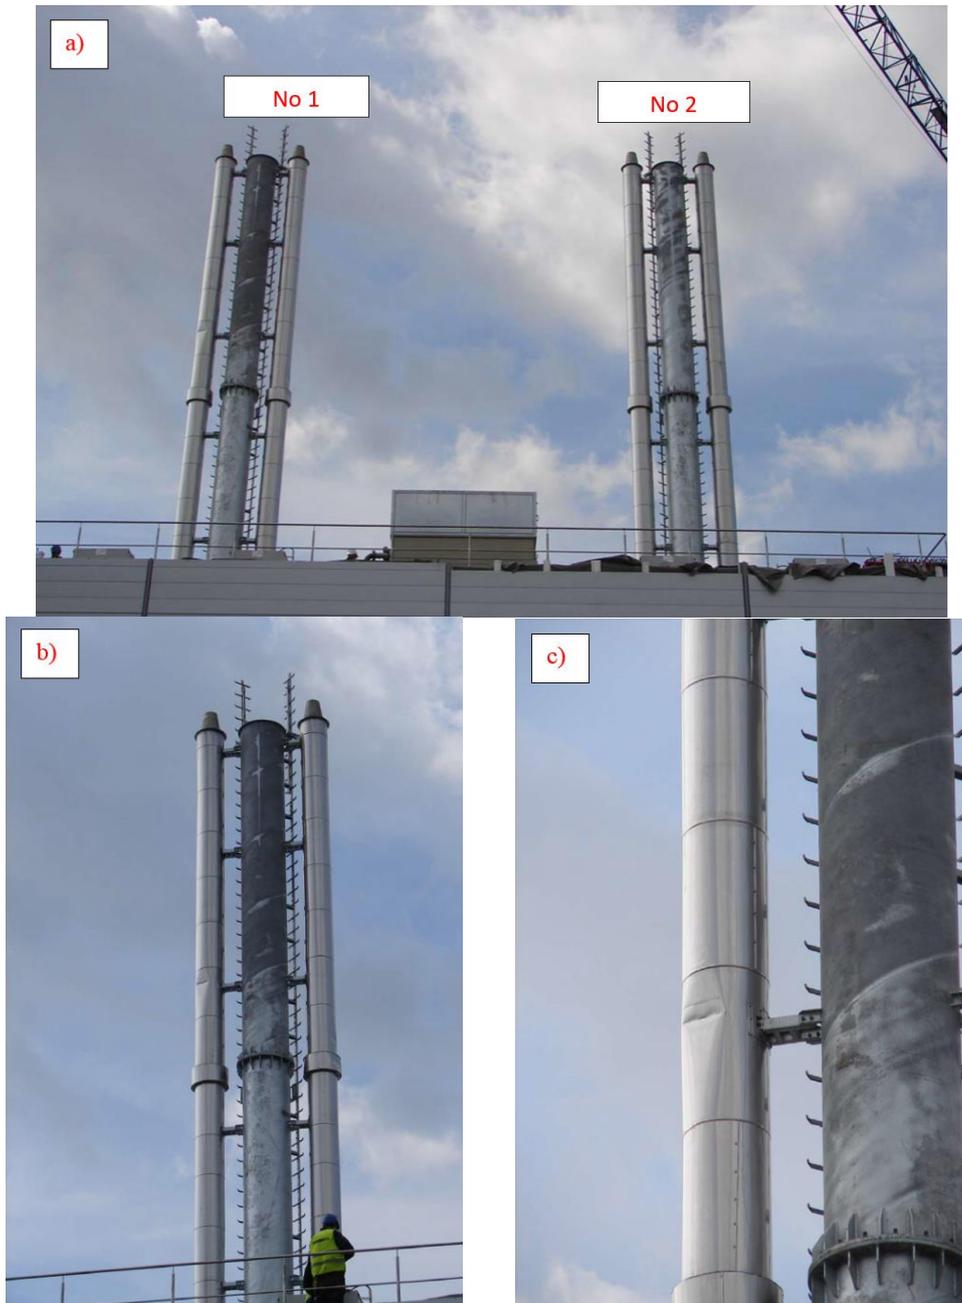
Fig. 1 a-c. Steel assembly of the chimney stack's load bearing shaft, together with flue gas pipes.

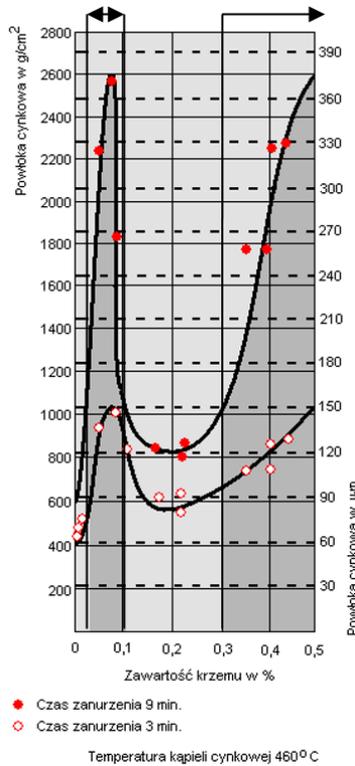
The impact of silicon content on the thickness of the zinc coating is illustrated by a Sandelin diagram in Fig. 6. The graph shows that the Sandelin effect occurs for silicon content of 0.03%–0.1% and above 0.3%. With silicon-containing steel, there is a risk that the iron-zinc reaction will be particularly powerful and that the proportion of iron-zinc alloy in the zinc coating will be higher than normal. In extreme cases, the zinc coating may be made up of an iron-zinc alloy [7–8].

Fig. 6. A Sandelin diagram depicting the impact of silicon content on zinc coating thickness [8].
