## Analysis of damp in the substructure of a multi-family residential building – case study

**Abstract:** This paper discusses dampness in an underground garage of a multi-family residential building on the basis of a case study. Due to high groundwater levels, the building substructure was constructed using W8 watertight concrete. This applies to both the foundation slab and substructure walls. However, leaks have occurred even though the used solutions were in theory designed to protect the building substructure from rainwater ingress. Macroscopic in situ tests, boreholes in the garage hall floor and foundation slab as well as laboratory test to determine the watertightness of the concrete were carried out to determine the cause of this construction defect, manifesting itself as damp in the structural elements in question.

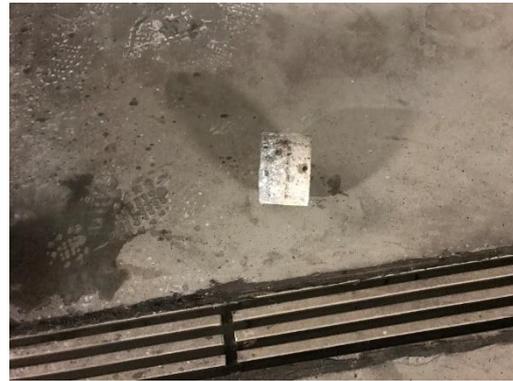
A borehole (Figure 2.1) was performed to check compliance of the constructed layers with the design and to take a sample for watertightness testing of concrete from the underground garage floor and foundation slab. The borehole made it possible to determine that the foundation slab below an approximately 10 cm thick floor (Figure 2.2 and Figure 2.3) was 27.7 cm thick (Figure 2.4 and Figure 2.5). According to the design documentation, the foundation slab should be 40–60 cm thick. At the borehole there was no separation layer (made of black construction film for example) between the floor and the foundation slab.

**Fig. 2.2.** Overall view of the borehole in the underground garage floor.

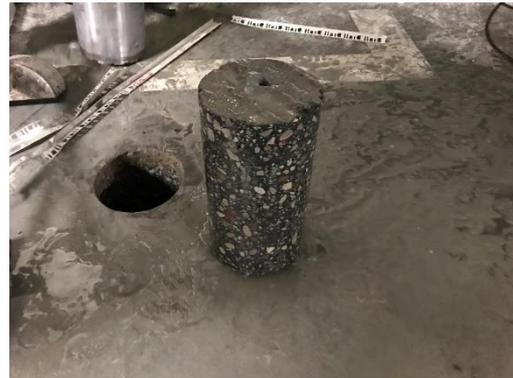
**Fig. 2.4.** Overall view of the borehole in the underground garage foundation slab.
